General Information

| Make | Toyota | Model | Avanza |
| Registration No. | NJF2304 | Chassis No. | MHFAA1BY3R0035692 |

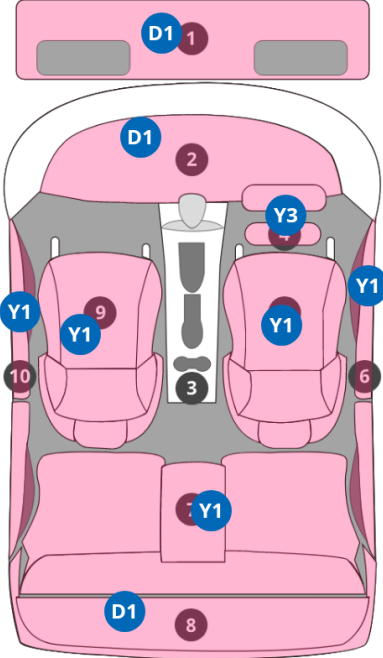
| Interior Evaluation : B | Exterior Evaluation : D |
| Remarks (L) Front Trim - Grime - Minimal / (L) Front Floor Mat - Grime - Medium / Dashboard - Worked - Minimal / (R) Front Trim - Grime - Minimal / Rear Seat - Grime - Minimal / Trunk Room - Worked - Minimal / (L) Front Seat - Grime - Minimal / (R) Front Seat - Grime - Minimal / Ceiling - Crinkle - Minimal | Remarks (L) Rear Door - Repair Traces - Yes / (L) Front Door, Molding - Scratch - Small / (L) Rear Door, Molding - Scratch - Small / (L) Step, In-panel, Side Spoiler - Scratch & Dent - Small / (L) Rear Fender, Molding - Scratch - Small / Rear Bumper, Lamps, Panels - Scratch - Medium / Trunk Hood, Rear Gate - Scratch & Dent - Minimal / (R) Rear Fender, Molding - Scratch & Dent - Minimal / (R) Rear Door, Molding - Scratch & Dent - Minimal / (R) Step, In-panel, Side Spoiler - Scratch & Dent - Small / (R) Front Door, Molding - Scratch & Dent - Minimal / (R) Front Fender, Molding - Scratch & Dent - Small / Bonnet, Headlight - Scratch - Large / Front Bumper, Grille, Lamps - Scratch & Dent - Small / Roof - Scratch & Dent - Small / (L) Front Fender, Molding - Scratch & Dent - Small |
