General Information

Date & Time: 26, Nov, 2025 15:42

Make	Toyota	Model	Hiace
YOM	2022	Odo Meter Reading	91,303
Registration No.	NIE5907	Chassis No.	JTFJT02P6N0015655
CC	3.0	Transmission	M/T
Fuel Type	Diesel	Type of Body	Utility Vehicle
Colour	White

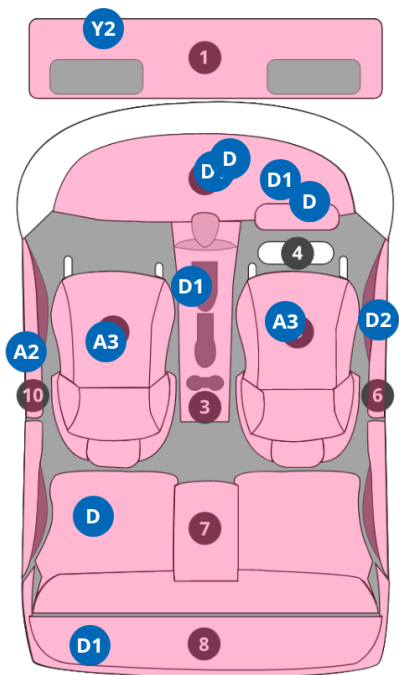
Interior Evaluation : C	Exterior Evaluation : E

<p>A : Scratch AU : Scratch & Dent B : Modified C : Corrosion G : Stone chip P : Faded S : Rust SC : Rust & Corrosion U : Dent X : Defective Y : Crack, Gap</p>
<p>Remarks Ceiling - Grime - Small / Dashboard - Worked - Minimal / Dashboard - Traces of Adhesive Tape - Yes / (R) Front Seat - Cut, Crack - Medium / (L) Front Seat - Cut, Crack - Medium / Rear Seat - Worn - Yes / (L) Front Trim - Cut, Crack - Small / (R) Front Trim - Worked - Small / Glove Box - Worked - Minimal / Trunk Room - Worked - Minimal / Console, Switches, Vents - Worked - Minimal / Glove Box - Traces of Adhesive Tape - Yes</p>	<p>Remarks (R) Front Door - Repair Traces - Yes / (R) Step - Repair Traces - Yes / (L) Front Door - Repair Traces - Yes / (L) Step - Repair Traces - Yes / Trunk Hood, Rear Gate - Repair Traces - Yes / (R) Rear Fender - Repair Traces - Yes / (R) Rear Door - Repair Traces - Yes / (R) Center Panel - Repair Traces - Yes / Roof - Repair Traces - Yes / (L) Rear Fender, Molding - Scratch - Medium / Trunk Hood, Rear Gate - Repair mark - Yes / Roof - Repair mark - Yes / Trunk Hood, Rear Gate - Scratch & Dent - Medium / Rear Bumper, Lamps, Panels - Scratch & Dent - Small / (R) Rear Fender, Molding - Scratch & Dent - Medium / (R) Center Panel - Scratch & Dent - Large / (R) Rear Door, Molding - Scratch & Dent - Large / (R) Rear Door, Molding - Repair mark - Yes / Roof - Scratch & Dent - Small / (R) Front Door, Molding - Scratch & Dent - Small / Front Panel - Scratch & Dent - Medium / Front Panel - Repair mark - Yes / Front Bumper, Grille, Lamps - Scratch & Dent - Small / (L) Rear Door, Molding - Scratch & Dent - Medium / (L) Front Door, Molding - Repair mark - Yes / (L) Front Door, Molding - Scratch & Dent - Small / (L) Front Fender, Molding - Scratch & Dent - Small / (R) Front Fender, Molding - Scratch & Dent - Small / (L) Step, In-panel, Side Spoiler - Scratch & Dent - Small / (R) Step, In-panel, Side Spoiler - Scratch & Dent - Small</p>
