## General Information

Date & Time: 16, Feb, 2026 15:27

<b>Make</b>	Toyota	<b>Model</b>	Vios
<b>YOM</b>	2020	<b>Odo Meter Reading</b>	75,902
<b>Registration No.</b>	NFV6414	<b>Chassis No.</b>	PA1B18F37L4112429
<b>CC</b>	1.3	<b>Transmission</b>	CVT
<b>Fuel Type</b>	Gas	<b>Type of Body</b>	Sedan
<b>Colour</b>	Green

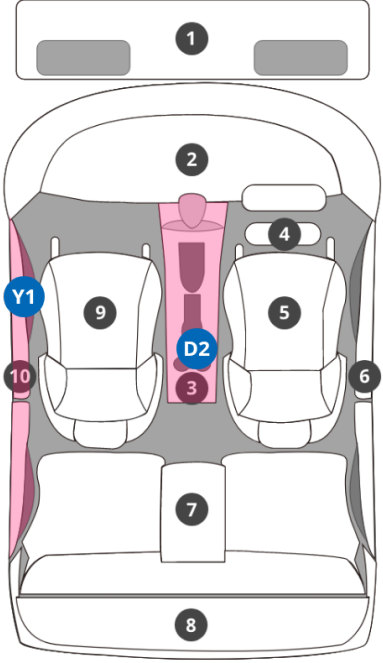
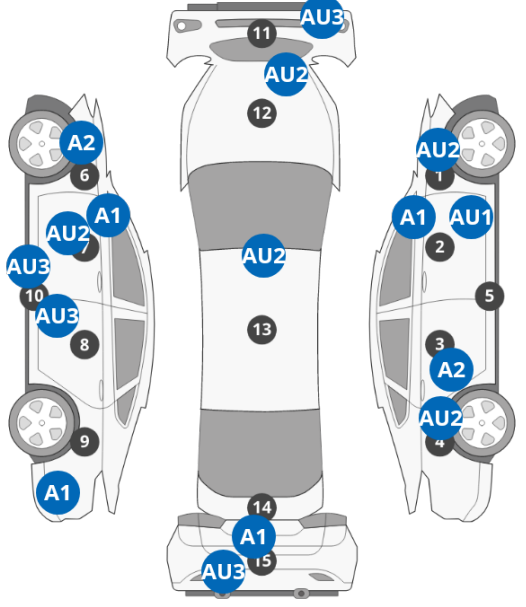
<b>Interior Evaluation :</b> <span style="color: red; font-size: 1.5em;">A</span>	<b>Exterior Evaluation :</b> <span style="color: red; font-size: 1.5em;">D</span>

<p><b>a</b> : Cut, Fray <b>d</b> : Loose, Deformed <b>k</b> : Animal Hair <b>s</b> : Smell <b>t</b> : Cigarette Burns <b>x</b> : Defective <b>y</b> : Stain</p>	<p><b>A</b> : Scratch <b>AU</b> : Scratch &amp; Dent <b>B</b> : Modified <b>C</b> : Corrosion <b>G</b> : Stone chip <b>P</b> : Faded <b>S</b> : Rust <b>SC</b> : Rust &amp; Corrosion <b>U</b> : Dent <b>X</b> : Defective <b>Y</b> : Crack, Gap</p>
<p><b>Remarks</b>            Console, Switches, Vents - Loose, Deformed - Small / (L)            Front Trim - Grime - Minimal</p>	<p><b>Remarks</b>            (R) Front Fender, Molding - Scratch &amp; Dent - Small / (R) Mirror - Scratch - Minimal / (R) Front Door, Molding - Scratch &amp; Dent - Minimal / (R) Rear Door, Molding - Scratch - Small / (R) Rear Fender, Molding - Scratch &amp; Dent - Small / Rear Bumper, Lamps, Panels - Scratch &amp; Dent - Medium / Trunk Hood, Rear Gate - Scratch - Minimal / (L) Rear Fender, Molding - Scratch - Minimal / (L) Rear Door, Molding - Scratch &amp; Dent - Medium / (L) Step, In-panel, Side Spoiler - Scratch &amp; Dent - Medium / (L) Front Door, Molding - Scratch &amp; Dent - Small / (L) Mirror - Scratch - Minimal / Bonnet, Headlight - Scratch &amp; Dent - Small / Front Bumper, Grille, Lamps - Scratch &amp; Dent - Medium / Roof - Scratch &amp; Dent - Small / (L) Front Fender, Molding - Scratch - Small</p>
