General Information

Make	Toyota	Model	Vios
YOM	2024	Odo Meter Reading	38,250
Registration No.	NFS9035	Chassis No.	PA1B18F36R4243313
CC	1.3	Transmission	CVT
Fuel Type	Gas	Type of Body	Sedan
Colour	Green

Body / Panel Condition

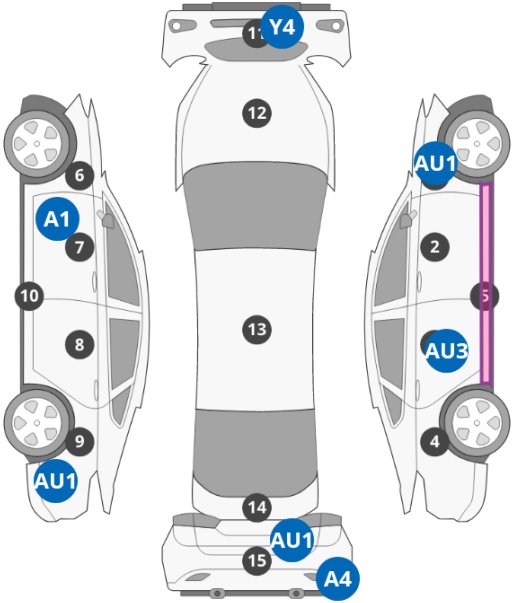
<p>A : Scratch AU : Scratch & Dent B : Modified C : Corrosion G : Stone chip P : Faded S : Rust SC : Rust & Corrosion U : Dent X : Defective Y : Crack, Gap</p>
<p>Remarks Defects not found</p>	<p>Remarks (R) Step - Repair Traces - Yes / (R) Front Fender, Molding - Scratch & Dent - Minimal / (R) Step, In-panel, Side Spoiler - Repair mark - Yes / (R) Rear Door, Molding - Scratch & Dent - Medium / Rear Bumper, Lamps, Panels - Scratch - Large / Trunk Hood, Rear Gate - Scratch & Dent - Minimal / (L) Rear Fender, Molding - Scratch & Dent - Minimal / (L) Front Door, Molding - Scratch - Minimal / Front Bumper, Grille, Lamps - Crack, Gap - Large</p>
Frame Evaluation : B	Functional Evaluation : B
<p>Remarks Front Cross Member Support - Traces of Bending, or Marks of Panel Repair ? - Yes</p>	<p>Remarks Battery - Weak - Yes / Reverse Camera - N/A - Yes / Spare Key - Issue - Unexist</p>
