## General Information

<b>Make</b>	Nissan	<b>Model</b>	NV350
<b>YOM</b>	2022	<b>Odo Meter Reading</b>	53,859
<b>Registration No.</b>	NFG6317	<b>Chassis No.</b>	JN1TC2E26Z0081376
<b>CC</b>	2.5	<b>Transmission</b>	M/T
<b>Fuel Type</b>	Diesel	<b>Type of Body</b>	Van
<b>Colour</b>	Gray

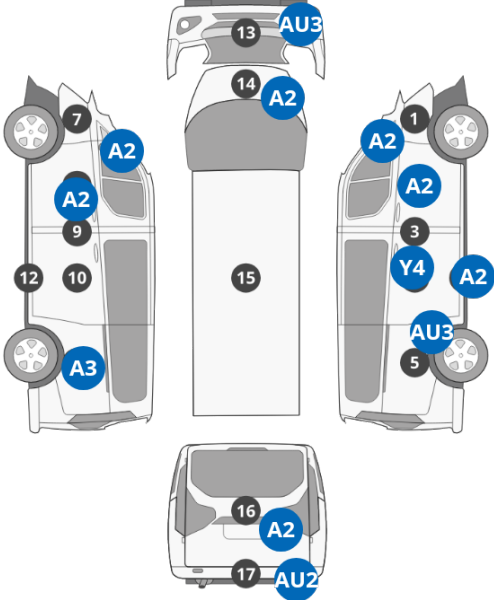
<p><b>A</b> : Scratch <b>AU</b> : Scratch &amp; Dent <b>B</b> : Modified <b>C</b> : Corrosion <b>G</b> : Stone chip <b>P</b> : Faded <b>S</b> : Rust <b>SC</b> : Rust &amp; Corrosion <b>U</b> : Dent <b>X</b> : Defective <b>Y</b> : Crack, Gap</p>
<p><b>Remarks</b> Rear Seat - Partially Missing - Yes / (R) Front Seat - Grime - Small / (L) Front Seat - Grime - Small</p>	<p><b>Remarks</b> (R) Step - Repair Traces - Yes / (R) Rear Fender - Repair Traces - Yes / (R) Rear Door, Molding - Crack, Gap - Large / (R) Front Door, Molding - Scratch - Small / (R) Rear Fender, Molding - Scratch &amp; Dent - Medium / (R) Step, In-panel, Side Spoiler - Scratch - Small / Rear Bumper, Lamps, Panels - Scratch &amp; Dent - Small / Trunk Hood, Rear Gate - Scratch - Small / (L) Rear Fender, Molding - Scratch - Medium / (L) Front Door, Molding - Scratch - Small / (L) Mirror - Scratch - Small / Bonnet, Headlight - Scratch - Small / Front Bumper, Grille, Lamps - Scratch &amp; Dent - Medium / (R) Front Fender, Molding - Scratch - Small</p>
