General Information

Date & Time: 05, Dec, 2025 13:03

Make	Mitsubishi	Model	Montero SPT
YOM	2014	Odo Meter Reading	105,844
Registration No.	WQX758	Chassis No.	MMBGRKG40ED006320
CC	2.5	Transmission	A/T
Fuel Type	Diesel	Type of Body	Sport Utility
Colour	Blue

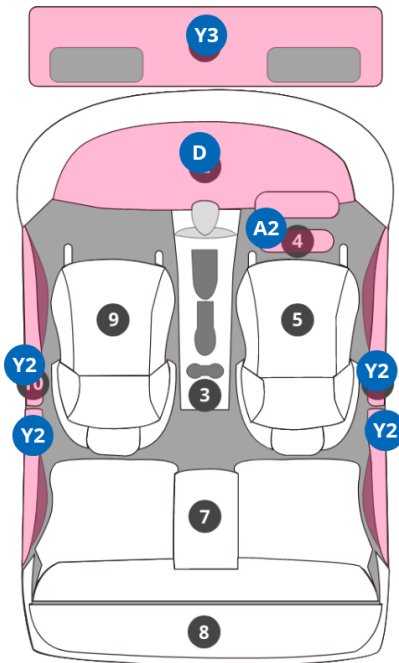
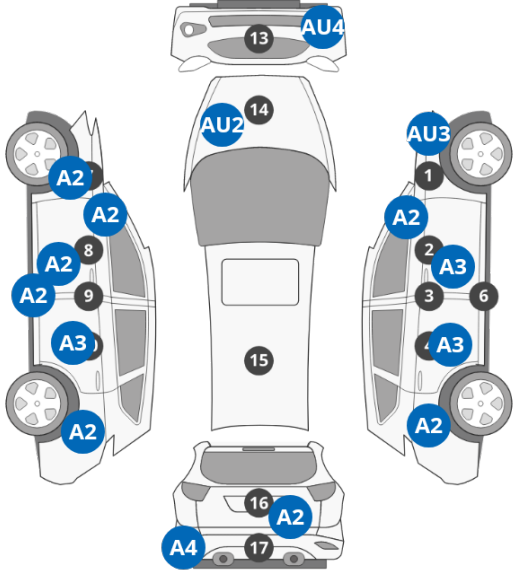
Interior Evaluation : B	Exterior Evaluation : E

<p>a : Cut, Fray d : Loose, Deformed k : Animal Hair s : Smell t : Cigarette Burns x : Defective y : Stain</p>	<p>A : Scratch AU : Scratch & Dent B : Modified C : Corrosion G : Stone chip P : Faded S : Rust SC : Rust & Corrosion U : Dent X : Defective Y : Crack, Gap</p>
<p>Remarks Ceiling - Grime - Medium / (R) Front Trim - Grime - Small / Dashboard - Traces of Adhesive Tape - Yes / (R) Rear Trim - Grime - Small / (L) Rear Trim - Grime - Small / (L) Front Trim - Grime - Small / (L) Front Floor Mat - Cut, Crack - Small</p>	<p>Remarks (L) Rear Fender - Repair Traces - Yes / (R) Front Door, Molding - Scratch - Medium / (R) Mirror - Scratch - Small / (R) Rear Door, Molding - Scratch - Medium / (R) Rear Fender, Molding - Scratch - Small / Rear Bumper, Lamps, Panels - Scratch - Large / Overall Exterior - Faded(Color, Gloss) - Yes / (L) Rear Fender, Molding - Scratch - Small / Trunk Hood, Rear Gate - Scratch - Small / (L) Rear Door, Molding - Scratch - Medium / (L) Step, In-panel, Side Spoiler - Scratch - Small / (L) Front Door, Molding - Scratch - Small / (L) Mirror - Scratch - Small / (L) Front Fender, Molding - Scratch - Small / Bonnet, Headlight - Scratch & Dent - Small / Front Bumper, Grille, Lamps - Scratch & Dent - Large / (R) Front Fender, Molding - Scratch & Dent - Medium</p>
