## General Information

<b>Make</b>	Toyota	<b>Model</b>	Hiace
<b>YOM</b>	2023	<b>Odo Meter Reading</b>	117,251
<b>Registration No.</b>	DBJ3685	<b>Chassis No.</b>	JTFJT02P9P5034528
<b>CC</b>	3.0	<b>Transmission</b>	M/T
<b>Fuel Type</b>	Diesel	<b>Type of Body</b>	Van
<b>Colour</b>	White

## Body / Panel Condition

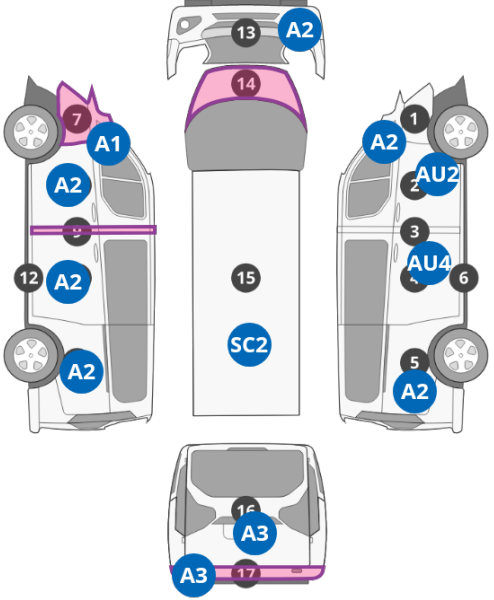
<p><b>A</b> : Scratch <b>AU</b> : Scratch &amp; Dent <b>B</b> : Modified <b>C</b> : Corrosion <b>G</b> : Stone chip <b>P</b> : Faded <b>S</b> : Rust <b>SC</b> : Rust &amp; Corrosion <b>U</b> : Dent <b>X</b> : Defective <b>Y</b> : Crack, Gap</p>
<p><b>Remarks</b> (L) Front Trim - Grime - Medium / (R) Front Trim - Grime - Small / Ceiling - Grime - Medium / Dashboard - Traces of Adhesive Tape - Yes / Rear Seat - Grime - Small</p>	<p><b>Remarks</b> Front Panel - Repair Traces - Yes / (L) Center Panel - Repair Traces - Yes / (L) Center Panel - Repair mark - Yes / Front Panel - Repair mark - Yes / (L) Mirror - Scratch - Minimal / Rear Bumper, Lamps, Panels - Repair mark - Yes / (R) Rear Door, Molding - Scratch &amp; Dent - Large / Rear Bumper, Lamps, Panels - Scratch - Medium / (R) Front Door, Molding - Scratch &amp; Dent - Small / (L) Front Door, Molding - Scratch - Small / (R) Mirror - Scratch - Small / (L) Rear Door, Molding - Scratch - Small / (R) Rear Fender, Molding - Scratch - Small / (L) Rear Fender, Molding - Scratch - Small / (L) Front Fender, Molding - Repair mark - Yes / Front Bumper, Grille, Lamps - Scratch - Small / Roof - Rust, Corrosion - Small / Trunk Hood, Rear Gate - Scratch - Medium</p>
