## General Information

<b>Make</b>	Toyota	<b>Model</b>	Corolla Altis
<b>YOM</b>	2016	<b>Odo Meter Reading</b>	97,829
<b>Registration No.</b>	GCS4257	<b>Chassis No.</b>	MR053REH104548193
<b>CC</b>	1.6	<b>Transmission</b>	A/T
<b>Fuel Type</b>	Gas	<b>Type of Body</b>	Sedan
<b>Colour</b>	Gray

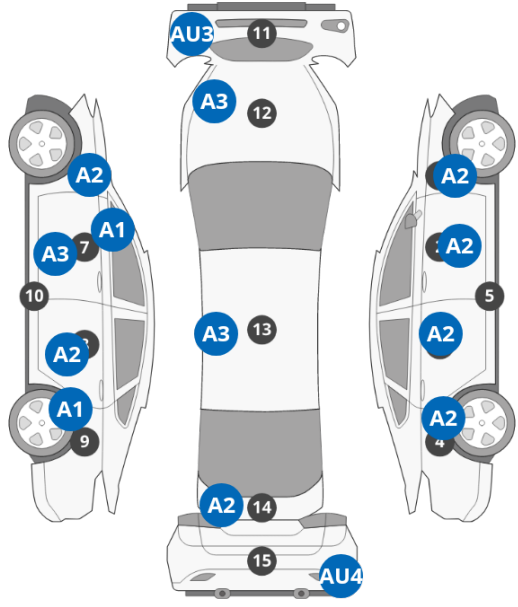
<p><b>A</b> : Scratch <b>AU</b> : Scratch &amp; Dent <b>B</b> : Modified <b>C</b> : Corrosion <b>G</b> : Stone chip <b>P</b> : Faded <b>S</b> : Rust <b>SC</b> : Rust &amp; Corrosion <b>U</b> : Dent <b>X</b> : Defective <b>Y</b> : Crack, Gap</p>
<p><b>Remarks</b> Ceiling - Grime - Medium / (R) Front Seat - Grime - Medium / Rear Seat - Grime - Medium / (L) Front Seat - Grime - Small</p>	<p><b>Remarks</b> (L) Step - Repair Traces - Yes / (L) Rear Door - Repair Traces - Yes / (L) Rear Fender - Repair Traces - Yes / (R) Rear Fender - Repair Traces - Yes / Bonnet, Headlight - Scratch - Medium / (R) Front Door, Molding - Scratch - Small / (R) Rear Door, Molding - Scratch - Small / (R) Front Fender, Molding - Scratch - Small / (R) Rear Fender, Molding - Scratch - Small / Rear Bumper, Lamps, Panels - Scratch &amp; Dent - Large / Trunk Hood, Rear Gate - Scratch - Small / (L) Rear Fender, Molding - Scratch - Minimal / (L) Rear Door, Molding - Scratch - Small / (L) Front Door, Molding - Scratch - Medium / (L) Mirror - Scratch - Minimal / (L) Front Fender, Molding - Scratch - Small / Roof - Scratch - Medium / Front Bumper, Grille, Lamps - Scratch &amp; Dent - Medium</p>
