General Information

Make	Toyota	Model	Lite Ace
YOM	2024	Odo Meter Reading	62,080
Registration No.	NHR5228	Chassis No.	MHKU3FE10PK005173
CC	1.5	Transmission	M/T
Fuel Type	Gas	Type of Body	Utility Vehicle
Colour	White

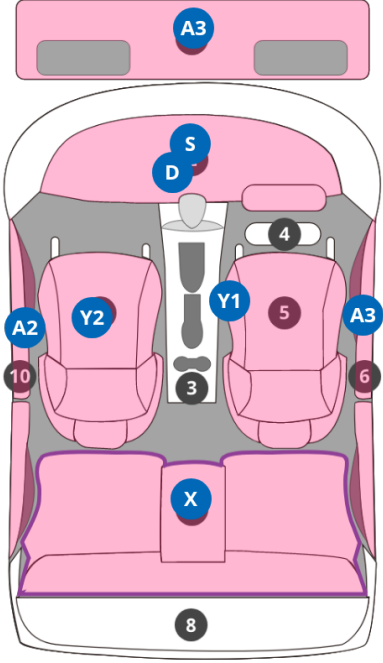
Interior Evaluation : C	Exterior Evaluation : E

<p>A : Scratch AU : Scratch & Dent B : Modified C : Corrosion G : Stone chip P : Faded S : Rust SC : Rust & Corrosion U : Dent X : Defective Y : Crack, Gap</p>
<p>Remarks Ceiling - Cut, Crack - Medium / Rear Seat - Missing - Yes / (R) Front Trim - Cut, Crack - Medium / Overall Interior - Worn as per age - Yes / Overall Interior - Smell - Yes / (L) Front Trim - Cut, Crack - Small / (R) Front Seat - Grime - Minimal / (L) Front Seat - Grime - Small / Dashboard - Traces of Adhesive Tape - Yes</p>	<p>Remarks (L) Rear Corner Panel - Repair Traces - Yes / (R) Front Fender, Molding - Scratch - Small / (R) Mirror - Scratch - Small / Front Windshield - Scratch, Stone chip - Large / (R) Front Door, Molding - Scratch - Medium / (R) Rear Door, Molding - Scratch - Small / (R) Step, In-panel, Side Spoiler - Scratch & Dent - Medium / (R) Side Gate - Scratch - Medium / Rear Bumper, Lamps, Panels - Rust, Corrosion - Large / Cargo Bed Floor - Scratch & Dent - Large / Cab Back Panel - Scratch & Dent - Large / Rear Gate - Scratch - Large / (L) Side Gate - Scratch & Dent - Large / (L) Front Door, Molding - Scratch - Medium / (L) Mirror - Scratch - Small / (L) Front Fender, Molding - Scratch - Small / Front Bumper, Grille, Lamps - Scratch - Medium / Front Panel - Scratch & Dent - Medium / Roof - Scratch - Small</p>

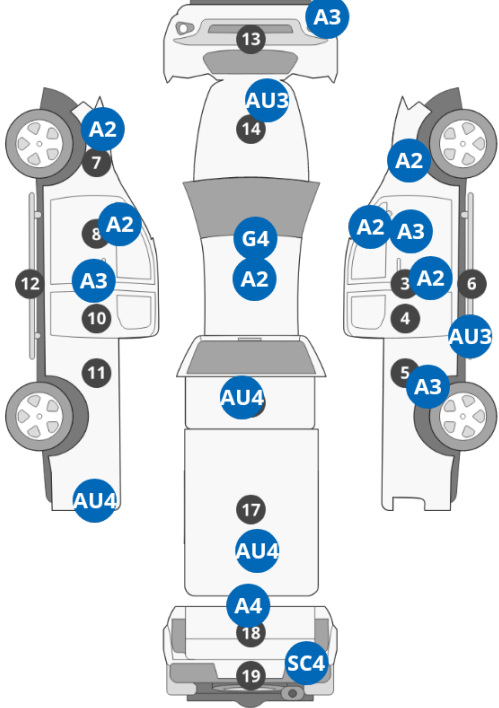
<p>Inspector Notes</p>
<p>no warranty booklet, with jack and tools, no spare tire, with LTO plate, scratches on headlight,</p>
