## General Information

<b>Make</b>	Toyota	<b>Model</b>	Corolla Cross
<b>YOM</b>	2024	<b>Odo Meter Reading</b>	22,381
<b>Registration No.</b>	NOW4421	<b>Chassis No.</b>	MR2KZAAG0P0079575
<b>CC</b>	1.8	<b>Transmission</b>	HEV CVT
<b>Fuel Type</b>	Hybrid	<b>Type of Body</b>	SUV
<b>Colour</b>	White

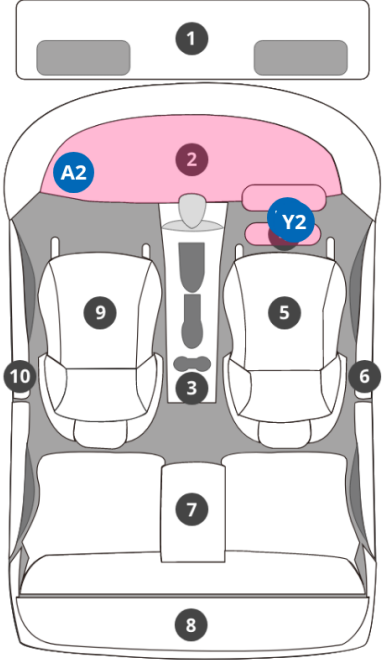
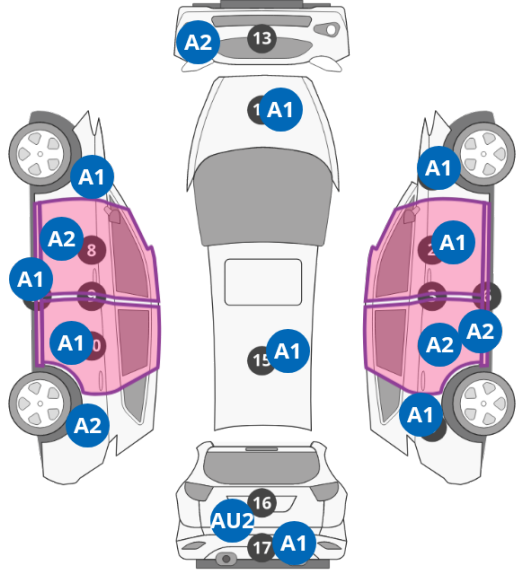
<b>Interior Evaluation :</b>	<b>A</b>	<b>Exterior Evaluation :</b>	<b>C</b>

<p><b>a</b> : Cut, Fray <b>d</b> : Loose, Deformed <b>k</b> : Animal Hair <b>s</b> : Smell <b>t</b> : Cigarette Burns <b>x</b> : Defective <b>y</b> : Stain</p>		<p><b>A</b> : Scratch <b>AU</b> : Scratch &amp; Dent <b>B</b> : Modified <b>C</b> : Corrosion <b>G</b> : Stone chip <b>P</b> : Faded <b>S</b> : Rust <b>SC</b> : Rust &amp; Corrosion <b>U</b> : Dent <b>X</b> : Defective <b>Y</b> : Crack, Gap</p>	
<p><b>Remarks</b> (L) Front Floor Mat - Worked - Small / Steering Wheel - Worn, Peel, Crack - Small / (R) Front Floor Mat - Grime - Small</p>		<p><b>Remarks</b> (R) Step - Repair Traces - Yes / (L) Front Door - Repair Traces - Yes / (L) Step - Repair Traces - Yes / (L) Front Door, Molding - Repair mark - Yes / (L) Rear Door, Molding - Repair mark - Yes / (R) Rear Door, Molding - Repair mark - Yes / (R) Front Door, Molding - Repair mark - Yes / (R) Step, In-panel, Side Spoiler - Repair mark - Yes / (L) Step, In-panel, Side Spoiler - Repair mark - Yes / (L) Front Fender, Molding - Scratch - Minimal / (L) Front Door, Molding - Scratch - Minimal / (L) Rear Door, Molding - Scratch - Minimal / (L) Step, In-panel, Side Spoiler - Scratch - Minimal / (L) Rear Fender, Molding - Scratch - Small / Trunk Hood, Rear Gate - Scratch &amp; Dent - Small / Rear Bumper, Lamps, Panels - Scratch - Minimal / (R) Rear Fender, Molding - Scratch - Minimal / (R) Rear Door, Molding - Scratch - Small / (R) Front Door, Molding - Scratch - Minimal / (R) Step, In-panel, Side Spoiler - Scratch - Small / (R) Front Fender, Molding - Scratch - Minimal / Bonnet, Headlight - Scratch - Minimal / Roof - Scratch - Minimal / Front Bumper, Grille, Lamps - Scratch - Small</p>
