General Information

Make	Toyota	Model	Hilux
YOM	2019	Odo Meter Reading	83,235
Registration No.	GAP9047	Chassis No.	MR0GB8DD7J1338934
CC	2.4	Transmission	M/T
Fuel Type	Diesel	Type of Body	Pickup
Colour	Black

Body / Panel Condition

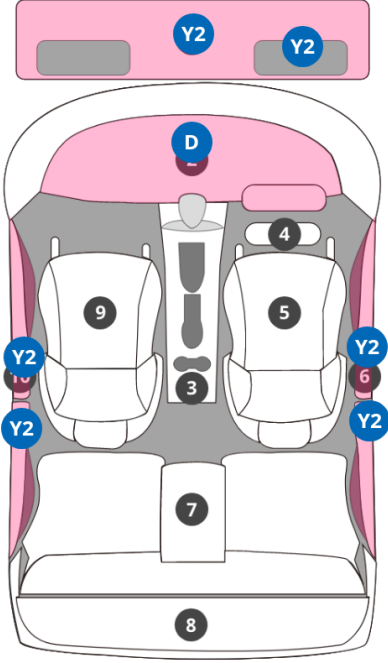
Interior Evaluation : B	Exterior Evaluation : E

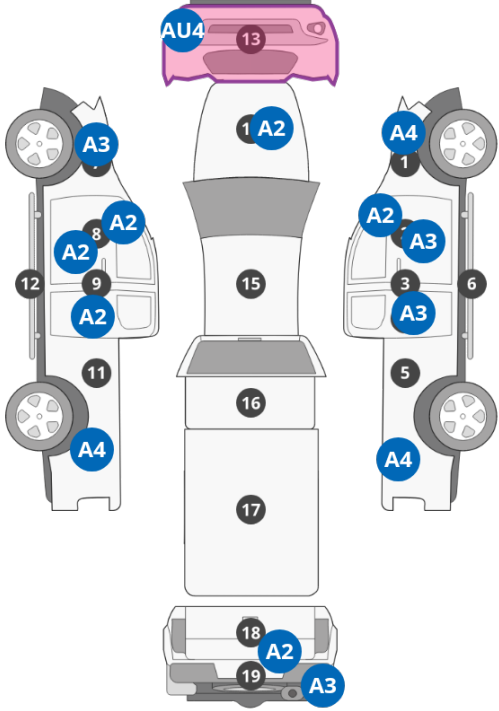
<p>A : Scratch AU : Scratch & Dent B : Modified C : Corrosion G : Stone chip P : Faded S : Rust SC : Rust & Corrosion U : Dent X : Defective Y : Crack, Gap</p>
<p>Remarks Ceiling - Grime - Small / Sunvisor, Sunglass Holder - Grime - Small / Dashboard - Traces of Adhesive Tape - Yes / (R) Rear Trim - Grime - Small / (R) Front Trim - Grime - Small / (L) Rear Trim - Grime - Small / (L) Front Trim - Grime - Small</p>	<p>Remarks (R) Front Door - Repair Traces - Yes / (R) Front Fender - Repair Traces - Yes / Bonnet - Repair Traces - Yes / (L) Front Fender - Repair Traces - Yes / (L) Front Door - Repair Traces - Yes / (L) Rear Door - Repair Traces - Yes / (L) Rear Corner Panel - Repair Traces - Yes / Roof - Repair Traces - Yes / (R) Front Fender, Molding - Scratch - Large / (R) Mirror - Scratch - Small / (R) Front Door, Molding - Scratch - Medium / (R) Rear Door, Molding - Scratch - Medium / (R) Side Gate - Scratch - Large / Rear Gate - Scratch - Small / Rear Bumper, Lamps, Panels - Scratch - Medium / (L) Side Gate - Scratch - Large / (L) Mirror - Scratch - Small / (L) Rear Door, Molding - Scratch - Small / (L) Front Door, Molding - Scratch - Small / (L) Front Fender, Molding - Scratch - Medium / Front Bumper, Grille, Lamps - Scratch & Dent - Large / Front Bumper, Grille, Lamps - Repair mark - Yes / Bonnet, Headlight - Scratch - Small</p>
