## General Information

<b>Make</b>	Toyota	<b>Model</b>	Vios
<b>YOM</b>	2025	<b>Odo Meter Reading</b>	8,211
<b>Registration No.</b>	CCG9083	<b>Chassis No.</b>	PA1B18F36S4286877
<b>CC</b>	1.3	<b>Transmission</b>	CVT
<b>Fuel Type</b>	Gas	<b>Type of Body</b>	Sedan
<b>Colour</b>	Blue

## Body / Panel Condition

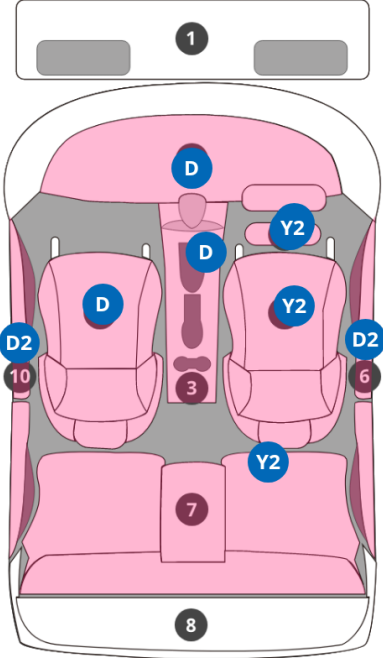
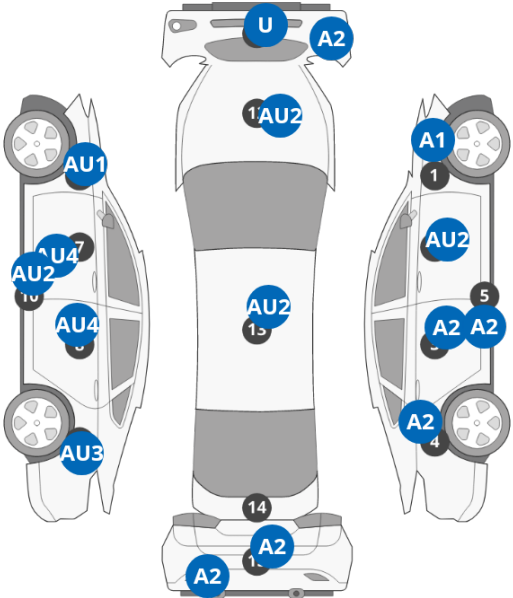
<b>Interior Evaluation :</b>	C	<b>Exterior Evaluation :</b>	E

<p><b>a</b> : Cut, Fray <b>d</b> : Loose, Deformed <b>k</b> : Animal Hair <b>s</b> : Smell <b>t</b> : Cigarette Burns <b>x</b> : Defective <b>y</b> : Stain</p>		<p><b>A</b> : Scratch <b>AU</b> : Scratch &amp; Dent <b>B</b> : Modified <b>C</b> : Corrosion <b>G</b> : Stone chip <b>P</b> : Faded <b>S</b> : Rust <b>SC</b> : Rust &amp; Corrosion <b>U</b> : Dent <b>X</b> : Defective <b>Y</b> : Crack, Gap</p>	
<p><b>Remarks</b> (L) Front Floor Mat - Worked - Small / (R) Front Floor Mat - Grime - Small / Mat Other - Grime - Small / (L) Front Trim - Worked - Small / (R) Front Trim - Worked - Small / (L) Front Seat - Worn - Yes / Dashboard - Traces of Adhesive Tape - Yes / Console, Switches, Vents - Traces of Adhesive Tape - Yes / Rear Seat - Grime - Small / (R) Front Seat - Grime - Small</p>		<p><b>Remarks</b> Member (Bolted) - Dent - Yes / (L) Front Door, Molding - Scratch &amp; Dent - Large / (L) Rear Door, Molding - Scratch &amp; Dent - Large / (L) Rear Fender, Molding - Scratch &amp; Dent - Medium / (L) Step, In-panel, Side Spoiler - Scratch &amp; Dent - Small / (L) Front Fender, Molding - Scratch &amp; Dent - Minimal / Bonnet, Headlight - Scratch &amp; Dent - Small / Front Bumper, Grille, Lamps - Scratch - Small / (R) Front Fender, Molding - Scratch - Minimal / (R) Front Door, Molding - Scratch &amp; Dent - Small / (R) Rear Door, Molding - Scratch - Small / (R) Step, In-panel, Side Spoiler - Scratch - Small / (R) Rear Fender, Molding - Scratch - Small / Trunk Hood, Rear Gate - Scratch - Small / Rear Bumper, Lamps, Panels - Scratch - Small / Roof - Scratch &amp; Dent - Small</p>

<b>Inspector Notes</b>
<p>With LTO plate and Sparetire, Warranty booklet, No spare, No Tools and Jack, Scratch headlight and tail light, Worn Tires and Sparetire, plate and room light issue, headlight issue and tail light crack.</p>
