## General Information

<b>Make</b>	Toyota	<b>Model</b>	Vios
<b>YOM</b>	2024	<b>Odo Meter Reading</b>	42,437
<b>Registration No.</b>	NHM2708	<b>Chassis No.</b>	PA1B18F34R424257
<b>CC</b>	1.3	<b>Transmission</b>	CVT
<b>Fuel Type</b>	Gas	<b>Type of Body</b>	Sedan
<b>Colour</b>	Silver

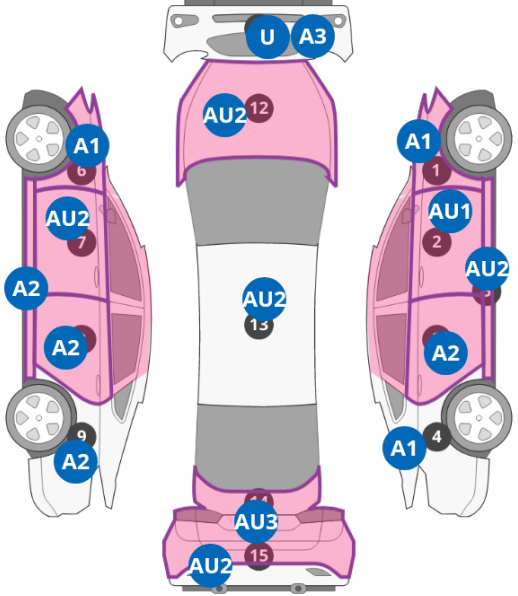
<p><b>A</b> : Scratch <b>AU</b> : Scratch &amp; Dent <b>B</b> : Modified <b>C</b> : Corrosion <b>G</b> : Stone chip <b>P</b> : Faded <b>S</b> : Rust <b>SC</b> : Rust &amp; Corrosion <b>U</b> : Dent <b>X</b> : Defective <b>Y</b> : Crack, Gap</p>
<p><b>Remarks</b> (L) Front Trim - Worked - Small / (L) Front Floor Mat - Worked - Small / (R) Front Trim - Worked - Small / Ceiling - Grime - Small / Overall Interior - Smell - Yes</p>	<p><b>Remarks</b> (R) Front Door - Repair Traces - Yes / (R) Step - Repair Traces - Yes / (R) Front Fender - Repair Traces - Yes / Bonnet - Repair Traces - Yes / (L) Front Fender - Repair Traces - Yes / (L) Front Door - Repair Traces - Yes / (L) Step - Repair Traces - Yes / Trunk Hood, Rear Gate - Repair Traces - Yes / (R) Rear Door - Repair Traces - Yes / Member (Bolted) - Dent - Yes / (L) Front Fender, Molding - Repair mark - Yes / Bonnet, Headlight - Repair mark - Yes / (R) Front Fender, Molding - Repair mark - Yes / (R) Front Door, Molding - Repair mark - Yes / (R) Rear Door, Molding - Repair mark - Yes / (L) Step, In-panel, Side Spoiler - Repair mark - Yes / (L) Step, In-panel, Side Spoiler - Repair mark - Yes / (L) Rear Door, Molding - Repair mark - Yes / (L) Front Door, Molding - Repair mark - Yes / Trunk Hood, Rear Gate - Repair mark - Yes / (L) Front Fender, Molding - Scratch - Minimal / (L) Front Door, Molding - Scratch &amp; Dent - Small / (L) Rear Door, Molding - Scratch - Small / (L) Step, In-panel, Side Spoiler - Scratch - Small / Front Bumper, Grille, Lamps - Scratch - Medium / (R) Front Fender, Molding - Scratch - Minimal / (R) Front Door, Molding - Scratch &amp; Dent - Minimal / (R) Step, In-panel, Side Spoiler - Scratch &amp; Dent - Small / (R) Rear Door, Molding - Scratch - Small / (R) Rear Fender, Molding - Scratch - Minimal / Trunk Hood, Rear Gate - Scratch &amp; Dent - Medium / Rear Bumper, Lamps, Panels - Scratch &amp; Dent - Small / Roof - Scratch &amp; Dent - Small / (L) Rear Fender, Molding - Scratch - Small / Bonnet, Headlight - Scratch &amp; Dent - Small</p>
