General Information

Make	Toyota	Model	Avanza
YOM	2025	Odo Meter Reading	5,009
Registration No.	NHU9696	Chassis No.	MHFAA1BYR0035386
CC	1.3	Transmission	CVT
Fuel Type	Gas	Type of Body	MPV
Colour	Green

Body / Panel Condition

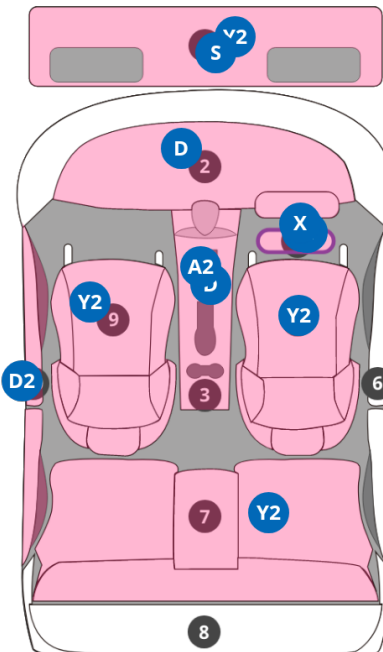
Interior Evaluation : B	Exterior Evaluation : E

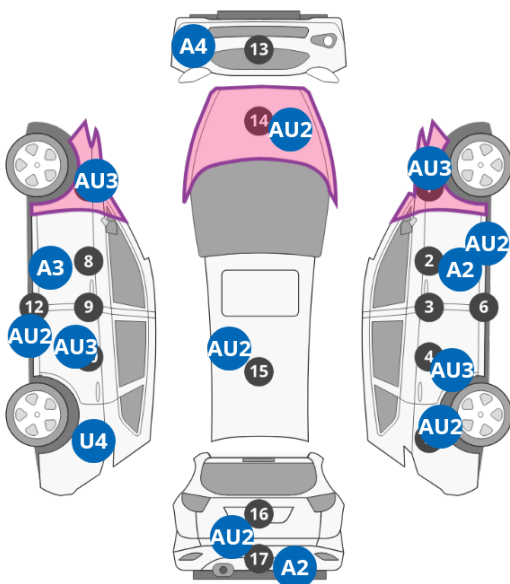
<p>A : Scratch AU : Scratch & Dent B : Modified C : Corrosion G : Stone chip P : Faded S : Rust SC : Rust & Corrosion U : Dent X : Defective Y : Crack, Gap</p>
<p>Remarks Ceiling - Grime - Small / Overall Interior - Smell - Yes / Dashboard - Traces of Adhesive Tape - Yes / (L) Front Trim - Worked - Small / (L) Front Seat - Grime - Small / (R) Front Seat - Grime - Small / Rear Seat - Grime - Small / (L) Front Floor Mat - Worked - Small / (R) Front Floor Mat - Missing - Yes / (L) Front Floor Mat - Missing - Yes / Mat Other - Missing - Yes / Console, Switchs, Vents - Traces of Adhesive Tape - Yes / Console, Switchs, Vents - Worn, Scratch, Cut, Crack - Small</p>	<p>Remarks (R) Front Fender - Repair Traces - Yes / Bonnet - Repair Traces - Yes / (L) Front Fender - Repair Traces - Yes / Front Bumper, Grille, Lamps - Scratch - Large / (L) Front Fender, Molding - Scratch & Dent - Medium / (L) Front Door, Molding - Scratch - Medium / (L) Step, In-panel, Side Spoiler - Scratch & Dent - Small / (L) Rear Door, Molding - Scratch & Dent - Medium / (L) Rear Fender, Molding - Dent - Large / Trunk Hood, Rear Gate - Scratch & Dent - Small / Rear Bumper, Lamps, Panels - Scratch - Small / (R) Rear Fender, Molding - Scratch & Dent - Small / (R) Rear Door, Molding - Scratch & Dent - Medium / (R) Front Door, Molding - Scratch - Small / (R) Step, In-panel, Side Spoiler - Scratch & Dent - Small / (R) Front Fender, Molding - Scratch & Dent - Medium / Roof - Scratch & Dent - Small / Bonnet, Headlight - Scratch & Dent - Small / (L) Front Fender, Molding - Repair mark - Yes / Bonnet, Headlight - Repair mark - Yes / (R) Front Fender, Molding - Repair mark - Yes</p>
