General Information

Make	Toyota	Model	Avanza
YOM	2022	Odo Meter Reading	35,271
Registration No.	NFL8037	Chassis No.	MHFAA1BY7N0004696
CC	1.3	Transmission	CVT
Fuel Type	Gas	Type of Body	Wagon
Colour	Black

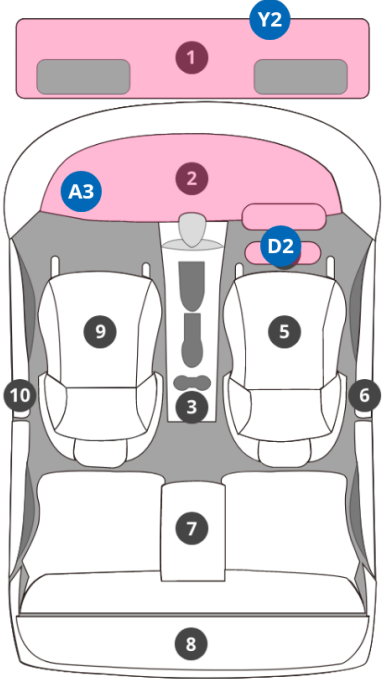
Interior Evaluation : B	Exterior Evaluation : E

<p>a : Cut, Fray d : Loose, Deformed k : Animal Hair s : Smell t : Cigarette Burns x : Defective y : Stain</p>

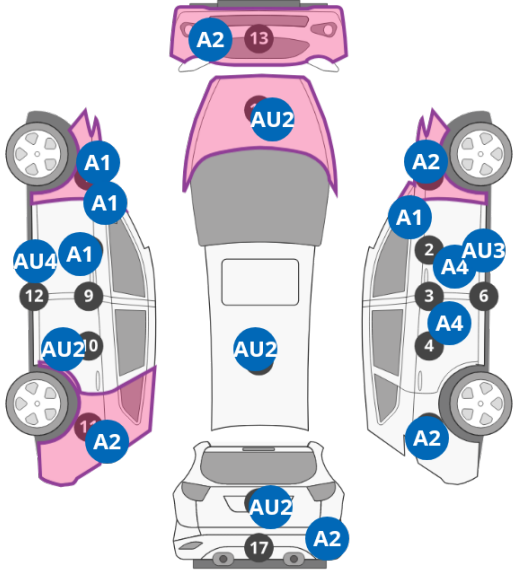
<p>A : Scratch AU : Scratch & Dent B : Modified C : Corrosion G : Stone chip P : Faded S : Rust SC : Rust & Corrosion U : Dent X : Defective Y : Crack, Gap</p>
<p>Remarks Ceiling - Grime - Small / (L) Front Floor Mat - Worked - Small / Steering Wheel - Worn, Peel, Crack - Medium</p>	<p>Remarks (R) Front Fender - Repair Traces - Yes / Bonnet - Repair Traces - Yes / (L) Front Fender - Repair Traces - Yes / (L) Front Door - Repair Traces - Yes / (L) Step - Repair Traces - Yes / (L) Rear Fender - Repair Traces - Yes / (L) Rear Fender, Molding - Repair mark - Yes / (L) Front Fender, Molding - Repair mark - Yes / Bonnet, Headlight - Repair mark - Yes / (R) Front Fender, Molding - Repair mark - Yes / (L) Front Fender, Molding - Scratch - Minimal / (L) Front Door, Molding - Scratch - Minimal / (L) Rear Door, Molding - Scratch & Dent - Small / (L) Rear Fender, Molding - Scratch - Small / (L) Step, In-panel, Side Spoiler - Scratch & Dent - Large / Trunk Hood, Rear Gate - Scratch & Dent - Small / Rear Bumper, Lamps, Panels - Scratch - Small / (R) Rear Fender, Molding - Scratch - Small / (R) Rear Door, Molding - Scratch - Large / (R) Front Door, Molding - Scratch - Large / (R) Step, In-panel, Side Spoiler - Scratch & Dent - Medium / (R) Front Fender, Molding - Scratch - Small / (R) Mirror - Scratch - Minimal / (L) Mirror - Scratch - Minimal / Bonnet, Headlight - Scratch & Dent - Small / Front Bumper, Grille, Lamps - Repair mark - Difference in Color / Front Bumper, Grille, Lamps - Scratch - Small / Roof - Scratch & Dent - Small</p>
