General Information

Make	Toyota	Model	Vios
YOM	2025	Odo Meter Reading	20,035
Registration No.	CCG2152	Chassis No.	PA1B18F36R4276084
CC	1.3	Transmission	CVT
Fuel Type	Gas	Type of Body	Sedan
Colour	Blackish Red Mica

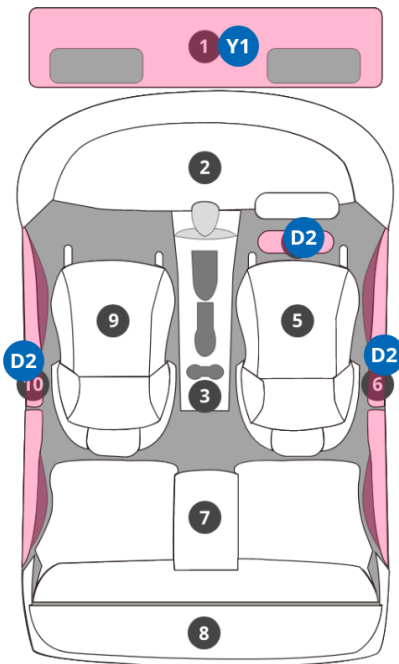
Interior Evaluation : A	Exterior Evaluation : D

<p>a : Cut, Fray d : Loose, Deformed k : Animal Hair s : Smell t : Cigarette Burns x : Defective y : Stain</p>

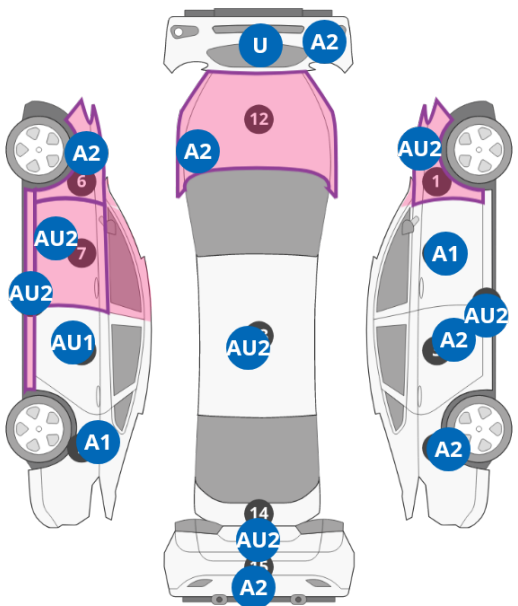
<p>A : Scratch AU : Scratch & Dent B : Modified C : Corrosion G : Stone chip P : Faded S : Rust SC : Rust & Corrosion U : Dent X : Defective Y : Crack, Gap</p>
<p>Remarks (L) Front Floor Mat - Worked - Small / (L) Front Trim - Worked - Small / (R) Front Trim - Worked - Small / Ceiling - Grime - Minimal</p>	<p>Remarks (R) Front Fender - Repair Traces - Yes / Bonnet - Repair Traces - Yes / (L) Front Fender - Repair Traces - Yes / (L) Front Door - Repair Traces - Yes / (L) Step - Repair Traces - Yes / (L) Rear Fender - Repair Traces - Yes / Roof - Repair Traces - Yes / (L) Front Fender, Molding - Repair mark - Yes / Bonnet, Headlight - Repair mark - Yes / (R) Front Fender, Molding - Repair mark - Yes / (L) Front Door, Molding - Repair mark - Yes / (L) Step, In-panel, Side Spoiler - Repair mark - Yes / Member (Bolted) - Dent - Yes / (L) Front Fender, Molding - Scratch - Small / (L) Front Door, Molding - Scratch & Dent - Small / (L) Rear Door, Molding - Scratch & Dent - Minimal / (L) Step, In-panel, Side Spoiler - Scratch & Dent - Small / (L) Rear Fender, Molding - Scratch - Minimal / Bonnet, Headlight - Scratch - Small / Front Bumper, Grille, Lamps - Scratch - Small / (R) Front Fender, Molding - Scratch & Dent - Small / (R) Front Door, Molding - Scratch - Minimal / (R) Rear Door, Molding - Scratch - Small / (R) Step, In-panel, Side Spoiler - Scratch & Dent - Small / (R) Rear Fender, Molding - Scratch - Small / Rear Bumper, Lamps, Panels - Scratch - Small / Trunk Hood, Rear Gate - Scratch & Dent - Small / Roof - Scratch & Dent - Small</p>
