General Information

Date & Time: 09, Dec, 2025 13:07

| Make | Toyota | Model | Vios |

Body / Panel Condition

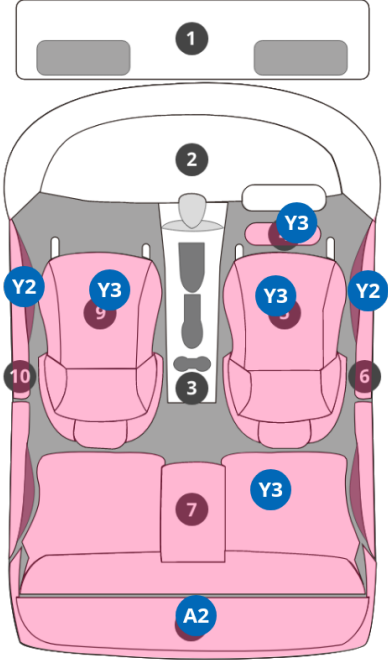
| <p>Remarks Rear Seat - Grime - Medium / Mat Other - Grime - Medium / (R) Front Trim - Grime - Small / (R) Front Seat - Grime - Medium / Trunk Room - Worn, Scratch, Cut, Crack - Small / (L) Front Trim - Grime - Small / (L) Front Seat - Grime - Medium</p> | <p>Remarks (L) Front Fender, Molding - Scratch & Dent - Medium / Front Bumper, Grille, Lamps - Scratch & Dent - Medium / (R) Front Fender, Molding - Scratch & Dent - Medium / (R) Front Door, Molding - Scratch & Dent - Large / (R) Step, In-panel, Side Spoiler - Scratch & Dent - Large / (R) Rear Door, Molding - Scratch & Dent - Large / (R) Rear Fender, Molding - Scratch & Dent - Large / Rear Bumper, Lamps, Panels - Scratch - Medium / Trunk Hood, Rear Gate - Scratch - Small / (L) Rear Fender, Molding - Scratch - Small / (L) Rear Door, Molding - Scratch - Small / (L) Front Door, Molding - Scratch - Small / Roof - Scratch - Medium / Bonnet, Headlight - Scratch - Medium / (R) Mirror - Scratch - Minimal / (L) Mirror - Scratch - Minimal</p> |
