## General Information

<b>Make</b>	Toyota	<b>Model</b>	Wigo
<b>YOM</b>	2022	<b>Odo Meter Reading</b>	27,722
<b>Registration No.</b>	NFG2958	<b>Chassis No.</b>	MHKA4DF5FMJ062100
<b>CC</b>	1.0	<b>Transmission</b>	A/T
<b>Fuel Type</b>	Gas	<b>Type of Body</b>	Hatchback
<b>Colour</b>	Black

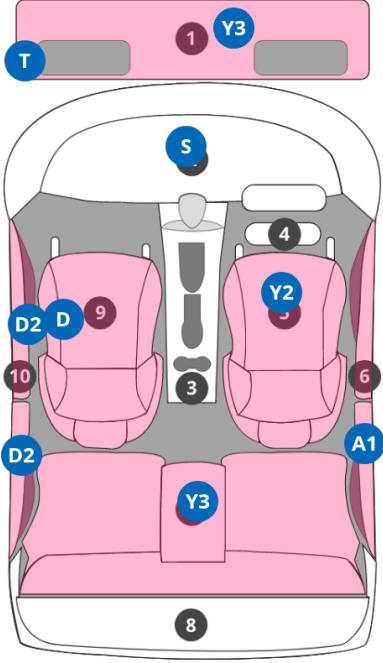
<p><b>a</b> : Cut, Fray <b>d</b> : Loose, Deformed <b>k</b> : Animal Hair <b>s</b> : Smell <b>t</b> : Cigarette Burns <b>x</b> : Defective <b>y</b> : Stain</p>

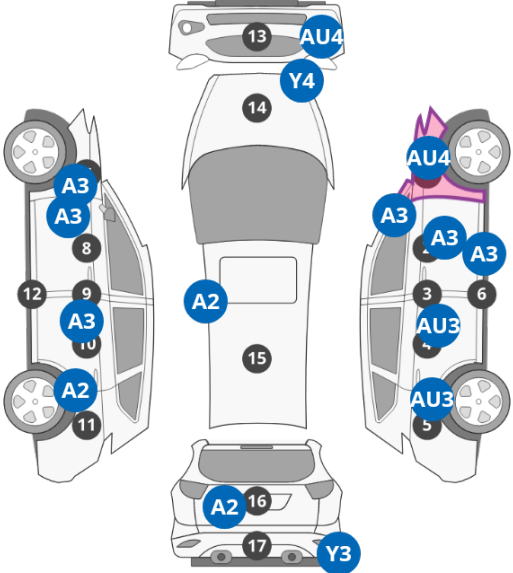
<p><b>A</b> : Scratch <b>AU</b> : Scratch &amp; Dent <b>B</b> : Modified <b>C</b> : Corrosion <b>G</b> : Stone chip <b>P</b> : Faded <b>S</b> : Rust <b>SC</b> : Rust &amp; Corrosion <b>U</b> : Dent <b>X</b> : Defective <b>Y</b> : Crack, Gap</p>
<p><b>Remarks</b> Overall Interior - Smell - Yes / (R) Front Seat - Grime - Small / (L) Front Seat - Worn - Yes / Rear Seat - Grime - Medium / (R) Rear Trim - Cut, Crack - Minimal / (L) Rear Trim - Worked - Small / (L) Front Trim - Worked - Small / Ceiling - Grime - Medium / Ceiling - Cigarette Burns - Burnt</p>	<p><b>Remarks</b> (R) Front Fender - Repair Traces - Yes / (R) Front Fender, Molding - Repair mark - Difference in Color / (R) Front Fender, Molding - Scratch &amp; Dent - Large / (R) Mirror - Scratch - Medium / (R) Front Door, Molding - Scratch - Medium / (R) Step, In-panel, Side Spoiler - Scratch - Medium / (R) Rear Door, Molding - Scratch &amp; Dent - Medium / (R) Rear Fender, Molding - Scratch &amp; Dent - Medium / Rear Bumper, Lamps, Panels - Crack, Gap - Medium / Trunk Hood, Rear Gate - Scratch - Small / (L) Rear Fender, Molding - Scratch - Small / (L) Rear Door, Molding - Scratch - Medium / (L) Front Door, Molding - Scratch - Medium / (L) Front Fender, Molding - Scratch - Medium / Front Bumper, Grille, Lamps - Scratch &amp; Dent - Large / Bonnet, Headlight - Crack, Gap - Large / Roof - Scratch - Small</p>
