## General Information

| <b>Make</b> | Toyota | <b>Model</b> | Vios |
| <b>Registration No.</b> | NFG3061 | <b>Chassis No.</b> | PA1B18F35M4164725 |

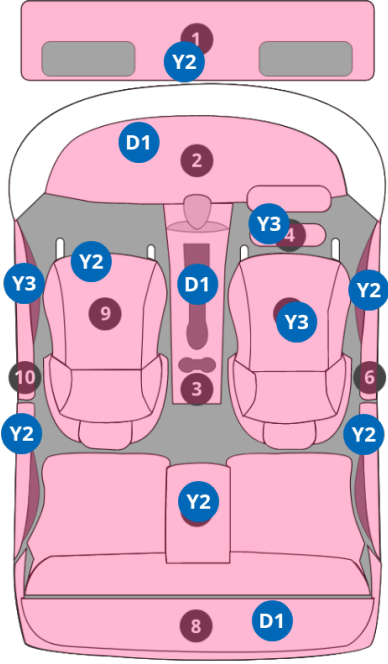
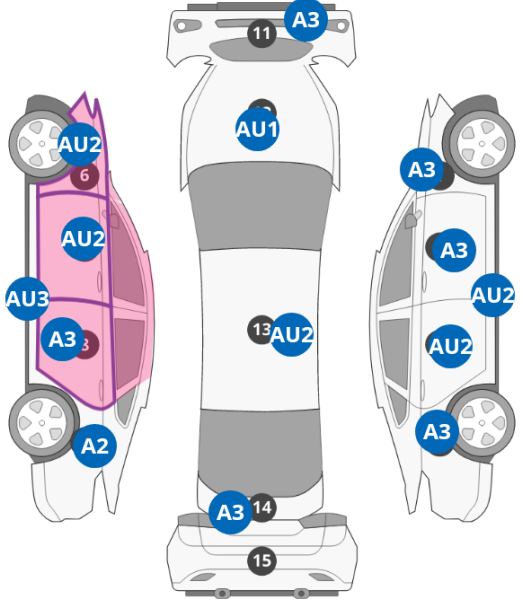
| <b>Interior Evaluation :</b> <span style="float: right; color: red; font-weight: bold;">C</span> | <b>Exterior Evaluation :</b> <span style="float: right; color: red; font-weight: bold;">E</span> |

| <p><b>Remarks</b><br/>(R) Front Trim - Grime - Small / (L) Front Trim - Grime - Medium / (R) Front Seat - Grime - Medium / Console, Switchs, Vents - Worked - Minimal / Dashboard - Worked - Minimal / Rear Seat - Grime - Small / (L) Front Floor Mat - Grime - Medium / (L) Front Seat - Grime - Small / Ceiling - Grime - Small / Trunk Room - Worked - Minimal / (L) Rear Trim - Grime - Small / (R) Rear Trim - Grime - Small</p> | <p><b>Remarks</b><br/>(R) Front Door - Repair Traces - Yes / (R) Front Fender - Repair Traces - Yes / Bonnet - Repair Traces - Yes / (L) Front Fender - Repair Traces - Yes / (L) Front Door - Repair Traces - Yes / (L) Step - Repair Traces - Yes / (L) Rear Door - Repair Traces - Yes / Trunk Hood, Rear Gate - Repair Traces - Yes / (R) Rear Fender - Repair Traces - Yes / (R) Rear Door - Repair Traces - Yes / Roof - Repair Traces - Yes / (L) Front Door, Molding - Repair mark - Yes / (L) Rear Door, Molding - Repair mark - Yes / (L) Front Fender, Molding - Repair mark - Yes / (L) Front Fender, Molding - Scratch &amp; Dent - Small / (L) Front Door, Molding - Scratch &amp; Dent - Small / (L) Step, In-panel, Side Spoiler - Scratch &amp; Dent - Medium / (L) Rear Door, Molding - Scratch - Medium / (L) Rear Fender, Molding - Scratch - Small / Trunk Hood, Rear Gate - Scratch - Medium / (R) Rear Fender, Molding - Scratch - Medium / (R) Rear Door, Molding - Scratch &amp; Dent - Small / (R) Front Door, Molding - Scratch - Medium / (R) Front Fender, Molding - Scratch - Medium / Bonnet, Headlight - Scratch &amp; Dent - Minimal / Front Bumper, Grille, Lamps - Scratch - Medium / Roof - Scratch &amp; Dent - Small / (R) Step, In-panel, Side Spoiler - Scratch &amp; Dent - Small</p> |
