## General Information

<b>Make</b>	Toyota	<b>Model</b>	Hiace
<b>YOM</b>	2022	<b>Odo Meter Reading</b>	31,778
<b>Registration No.</b>	NFJ2868	<b>Chassis No.</b>	JTFJT02P8M0015154
<b>CC</b>	3.0	<b>Transmission</b>	M/T
<b>Fuel Type</b>	Diesel	<b>Type of Body</b>	Van
<b>Colour</b>	White

## Body / Panel Condition

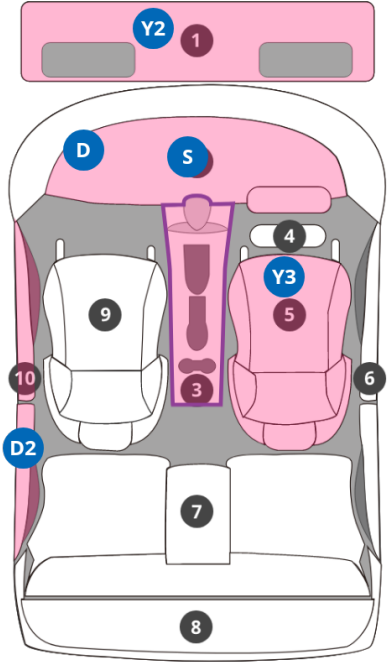
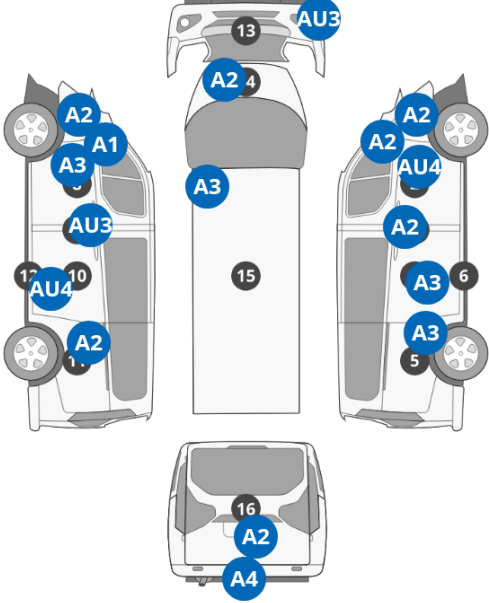
<b>Interior Evaluation :</b>	<b>C</b>	<b>Exterior Evaluation :</b>	<b>E</b>

<p><b>a</b> : Cut, Fray <b>d</b> : Loose, Deformed <b>k</b> : Animal Hair <b>s</b> : Smell <b>t</b> : Cigarette Burns <b>x</b> : Defective <b>y</b> : Stain</p>		<p><b>A</b> : Scratch <b>AU</b> : Scratch &amp; Dent <b>B</b> : Modified <b>C</b> : Corrosion <b>G</b> : Stone chip <b>P</b> : Faded <b>S</b> : Rust <b>SC</b> : Rust &amp; Corrosion <b>U</b> : Dent <b>X</b> : Defective <b>Y</b> : Crack, Gap</p>	
<p><b>Remarks</b> Overall Interior - Smell - Yes / Overall Interior - Worn as per age - Yes / (L) Front Trim - Worked - Small / Ceiling - Grime - Small / Display, Audio System - Missing - Yes / (R) Front Seat - Grime - Medium / Dashboard - Traces of Adhesive Tape - Yes</p>		<p><b>Remarks</b> (R) Rear Fender - Repair Traces - Yes / (R) Rear Door - Repair Traces - Yes / (R) Front Fender, Molding - Scratch - Small / (R) Front Door, Molding - Scratch &amp; Dent - Large / (R) Mirror - Scratch - Small / (R) Center Panel - Scratch - Small / (R) Rear Door, Molding - Scratch - Medium / (R) Rear Fender, Molding - Scratch - Medium / Rear Bumper, Lamps, Panels - Scratch - Large / Trunk Hood, Rear Gate - Scratch - Small / (L) Center Panel - Scratch &amp; Dent - Medium / (L) Rear Door, Molding - Scratch &amp; Dent - Large / (L) Rear Fender, Molding - Scratch - Small / (L) Front Door, Molding - Scratch - Medium / (L) Mirror - Scratch - Minimal / (L) Front Fender, Molding - Scratch - Small / Front Bumper, Grille, Lamps - Scratch &amp; Dent - Medium / Front Panel - Scratch - Small / Roof - Scratch - Medium</p>
