## General Information

Date & Time: 09, Dec, 2025 10:16

<b>Make</b>	Toyota	<b>Model</b>	Veloz
<b>YOM</b>	2024	<b>Odo Meter Reading</b>	18,378
<b>Registration No.</b>	NHM7470	<b>Chassis No.</b>	MHFAB1BY2P3072774
<b>CC</b>	1.5	<b>Transmission</b>	CVT
<b>Fuel Type</b>	Gas	<b>Type of Body</b>	Sedan
<b>Colour</b>	Red Mica Metallic

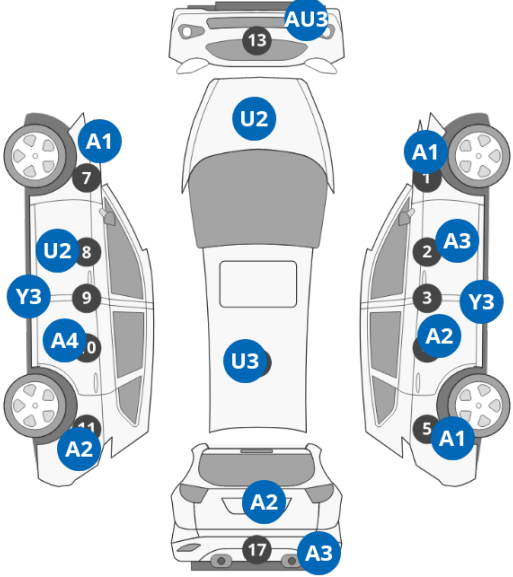
<p><b>A</b> : Scratch <b>AU</b> : Scratch &amp; Dent <b>B</b> : Modified <b>C</b> : Corrosion <b>G</b> : Stone chip <b>P</b> : Faded <b>S</b> : Rust <b>SC</b> : Rust &amp; Corrosion <b>U</b> : Dent <b>X</b> : Defective <b>Y</b> : Crack, Gap</p>
<p><b>Remarks</b> Rear Seat - Grime - Large / (R) Front Seat - Grime - Medium / (R) Front Trim - Grime - Small / (R) Rear Trim - Grime - Small / Trunk Room - Worn, Scratch, Cut, Crack - Medium / (L) Front Seat - Grime - Minimal / (L) Front Floor Mat - Grime - Small / Ceiling - Grime - Small</p>	<p><b>Remarks</b> Bonnet, Headlight - Dent - Small / (L) Front Door, Molding - Dent - Small / Roof - Dent - Medium / (R) Rear Door, Molding - Scratch - Small / (R) Step, In-panel, Side Spoiler - Crack, Gap - Medium / (R) Rear Fender, Molding - Scratch - Minimal / (R) Front Door, Molding - Scratch - Medium / Rear Bumper, Lamps, Panels - Scratch - Medium / Trunk Hood, Rear Gate - Scratch - Small / (L) Rear Fender, Molding - Scratch - Small / (L) Rear Door, Molding - Scratch - Large / (L) Step, In-panel, Side Spoiler - Crack, Gap - Medium / (R) Front Fender, Molding - Scratch - Minimal / Front Bumper, Grille, Lamps - Scratch &amp; Dent - Medium / (L) Front Fender, Molding - Scratch - Minimal</p>
