## General Information

<b>Make</b>	Toyota	<b>Model</b>	Avanza
<b>YOM</b>	2023	<b>Odo Meter Reading</b>	115,477
<b>Registration No.</b>	NIH5276	<b>Chassis No.</b>	MHFAA1BY8N0009292
<b>CC</b>	1.3	<b>Transmission</b>	CVT
<b>Fuel Type</b>	Gas	<b>Type of Body</b>	MPV
<b>Colour</b>	Red Mica Metallic

## Body / Panel Condition

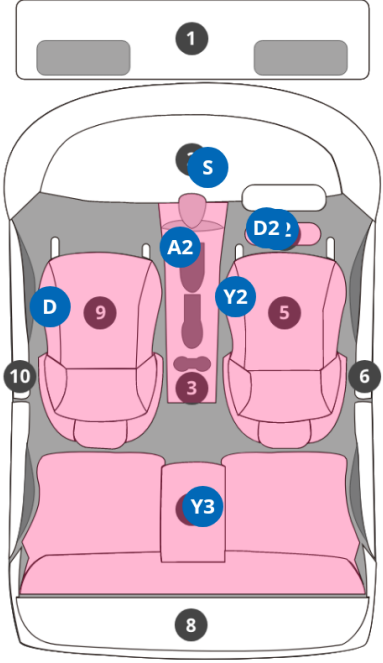
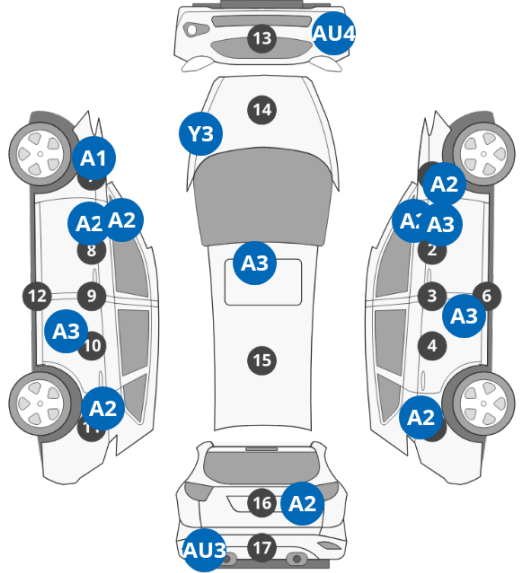
<b>Interior Evaluation :</b> <span style="float: right; color: red; font-weight: bold;">B</span>	<b>Exterior Evaluation :</b> <span style="float: right; color: red; font-weight: bold;">E</span>

<p><b>a</b> : Cut, Fray <b>d</b> : Loose, Deformed <b>k</b> : Animal Hair <b>s</b> : Smell <b>t</b> : Cigarette Burns <b>x</b> : Defective <b>y</b> : Stain</p>	<p><b>A</b> : Scratch <b>AU</b> : Scratch &amp; Dent <b>B</b> : Modified <b>C</b> : Corrosion <b>G</b> : Stone chip <b>P</b> : Faded <b>S</b> : Rust <b>SC</b> : Rust &amp; Corrosion <b>U</b> : Dent <b>X</b> : Defective <b>Y</b> : Crack, Gap</p>
<p><b>Remarks</b>  Overall Interior - Smell - Yes / (L) Front Seat - Worn - Yes / Rear Seat - Grime - Medium / (R) Front Seat - Grime - Small / Mat Other - Worked - Small / (R) Front Floor Mat - Worked - Small / (L) Front Floor Mat - Worked - Small / Knobs - Worn, Peel, Crack - Small</p>	<p><b>Remarks</b>  (R) Front Fender, Molding - Scratch - Small / (R) Mirror - Scratch - Small / (R) Rear Door, Molding - Scratch - Medium / (R) Front Door, Molding - Scratch - Medium / (R) Rear Fender, Molding - Scratch - Small / Rear Bumper, Lamps, Panels - Scratch &amp; Dent - Medium / Trunk Hood, Rear Gate - Scratch - Small / (L) Rear Fender, Molding - Scratch - Small / (L) Rear Door, Molding - Scratch - Medium / (L) Front Door, Molding - Scratch - Small / (L) Mirror - Scratch - Small / (L) Front Fender, Molding - Scratch - Minimal / Front Bumper, Grille, Lamps - Scratch &amp; Dent - Large / Bonnet, Headlight - Crack, Gap - Medium / Roof - Scratch - Medium</p>
