## General Information

<b>Make</b>	Toyota	<b>Model</b>	Vios
<b>YOM</b>	2021	<b>Odo Meter Reading</b>	81,263
<b>Registration No.</b>	NFQ6280	<b>Chassis No.</b>	PA1B18F39L4127949
<b>CC</b>	1.3	<b>Transmission</b>	CVT
<b>Fuel Type</b>	Gas	<b>Type of Body</b>	Sedan
<b>Colour</b>	Red

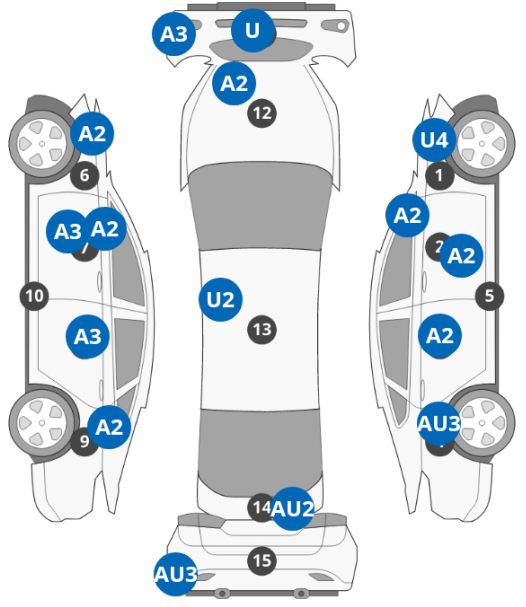
<p><b>A</b> : Scratch <b>AU</b> : Scratch &amp; Dent <b>B</b> : Modified <b>C</b> : Corrosion <b>G</b> : Stone chip <b>P</b> : Faded <b>S</b> : Rust <b>SC</b> : Rust &amp; Corrosion <b>U</b> : Dent <b>X</b> : Defective <b>Y</b> : Crack, Gap</p>
<p><b>Remarks</b> (L) Front Seat - Worn - Yes / (R) Front Seat - Grime - Small / (R) Front Trim - Grime - Small / (L) Front Trim - Worked - Small / (L) Front Trim - Grime - Medium / (L) Front Floor Mat - Worked - Small / Ceiling - Grime - Medium / Rear Seat - Grime - Minimal / Glove Box - Loose, Deformed - Medium</p>	<p><b>Remarks</b> (L) Rear Door - Repair Traces - Yes / (L) Rear Fender - Repair Traces - Yes / (R) Front Fender, Molding - Dent - Large / (R) Mirror - Scratch - Small / (R) Front Door, Molding - Scratch - Small / (R) Rear Door, Molding - Scratch - Small / (R) Rear Fender, Molding - Scratch &amp; Dent - Medium / Rear Bumper, Lamps, Panels - Scratch &amp; Dent - Medium / Trunk Hood, Rear Gate - Scratch &amp; Dent - Small / (L) Rear Fender, Molding - Scratch - Small / (L) Rear Door, Molding - Scratch - Medium / (L) Front Door, Molding - Scratch - Medium / (L) Mirror - Scratch - Small / (L) Front Fender, Molding - Scratch - Small / Member (Bolted) - Dent - Yes / Front Bumper, Grille, Lamps - Scratch - Medium / Bonnet, Headlight - Scratch - Small / Roof - Dent - Small</p>
