## General Information

Date & Time: 10, Dec, 2025 16:30

<b>Make</b>	Toyota	<b>Model</b>	Lite Ace
<b>YOM</b>	2024	<b>Odo Meter Reading</b>	8,809
<b>Registration No.</b>	NFS2302	<b>Chassis No.</b>	MHKU3FE10PK005312
<b>CC</b>	1.5	<b>Transmission</b>	M/T
<b>Fuel Type</b>	Gas	<b>Type of Body</b>	Utility Vehicle
<b>Colour</b>	White

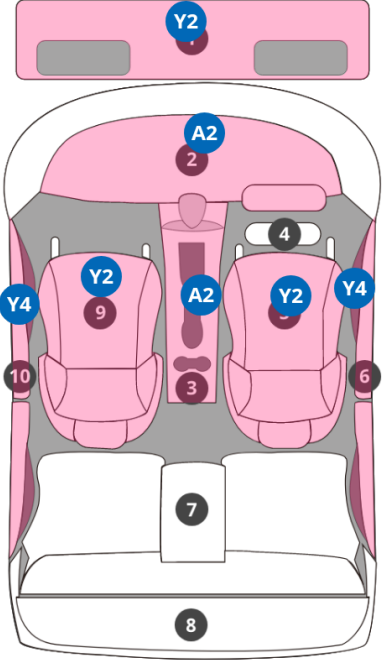
<b>Interior Evaluation :</b> <span style="float: right; color: red; font-weight: bold;">C</span>	<b>Exterior Evaluation :</b> <span style="float: right; color: red; font-weight: bold;">E</span>

<p><b>a</b> : Cut, Fray <b>d</b> : Loose, Deformed <b>k</b> : Animal Hair <b>s</b> : Smell <b>t</b> : Cigarette Burns <b>x</b> : Defective <b>y</b> : Stain</p>

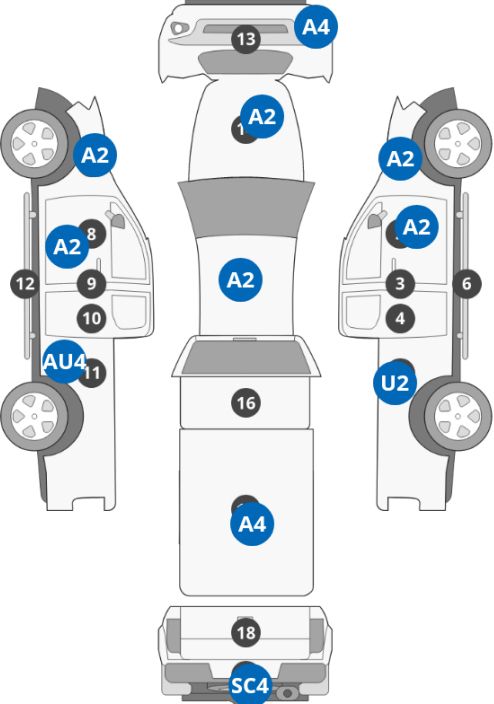
<p><b>A</b> : Scratch <b>AU</b> : Scratch &amp; Dent <b>B</b> : Modified <b>C</b> : Corrosion <b>G</b> : Stone chip <b>P</b> : Faded <b>S</b> : Rust <b>SC</b> : Rust &amp; Corrosion <b>U</b> : Dent <b>X</b> : Defective <b>Y</b> : Crack, Gap</p>
<p><b>Remarks</b> (R) Front Seat - Grime - Small / (R) Front Trim - Grime - Large / (L) Front Trim - Grime - Large / Dashboard - Worn, Scratch, Cut, Crack - Small / Console, Switches, Vents - Worn, Scratch, Cut, Crack - Small / (L) Front Seat - Grime - Small / Ceiling - Grime - Small</p>	<p><b>Remarks</b> Front Bumper, Grille, Lamps - Scratch - Large / (L) Side Gate - Scratch &amp; Dent - Large / Rear Bumper, Lamps, Panels - Rust, Corrosion - Large / Cargo Bed Floor - Scratch - Large / (L) Front Door, Molding - Scratch - Small / (R) Front Door, Molding - Scratch - Small / Front Panel - Scratch - Small / Roof - Scratch - Small / (R) Front Fender, Molding - Scratch - Small / (L) Front Fender, Molding - Scratch - Small / (R) Side Gate - Dent - Small</p>
