## General Information

<b>Make</b>	Toyota	<b>Model</b>	Vios
<b>YOM</b>	2024	<b>Odo Meter Reading</b>	8,669
<b>Registration No.</b>	DBJ8308	<b>Chassis No.</b>	PA1B18F38P4226543
<b>CC</b>	1.3	<b>Transmission</b>	CVT
<b>Fuel Type</b>	Gas	<b>Type of Body</b>	Sedan
<b>Colour</b>	Blue

## Body / Panel Condition

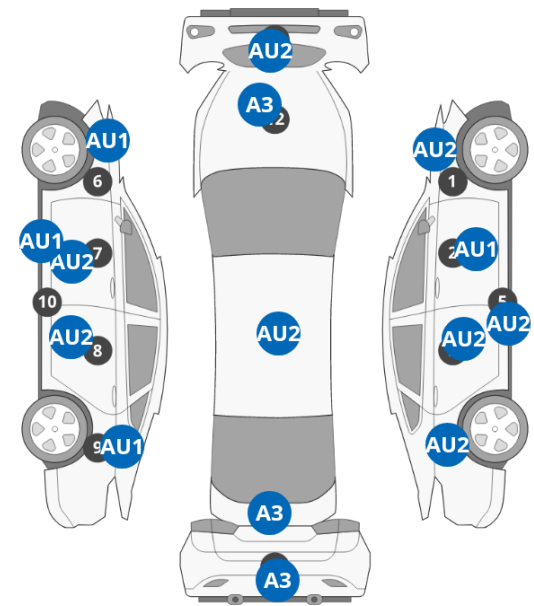
<p><b>A</b> : Scratch <b>AU</b> : Scratch &amp; Dent <b>B</b> : Modified <b>C</b> : Corrosion <b>G</b> : Stone chip <b>P</b> : Faded <b>S</b> : Rust <b>SC</b> : Rust &amp; Corrosion <b>U</b> : Dent <b>X</b> : Defective <b>Y</b> : Crack, Gap</p>
<b>Remarks</b> Ceiling - Grime - Small / (R) Front Seat - Grime - Small / (L) Front Seat - Grime - Small / Dashboard - Worked - Minimal / Rear Seat - Grime - Minimal / Console, Switchs, Vents - Worked - Minimal / (R) Front Floor Mat - Worked - Small / (L) Front Floor Mat - Worked - Small / (R) Front Trim - Grime - Minimal / (L) Front Trim - Grime - Minimal	<b>Remarks</b> (L) Front Door - Repair Traces - Yes / (R) Front Fender, Molding - Scratch & Dent - Small / (R) Front Door, Molding - Scratch & Dent - Minimal / (R) Rear Door, Molding - Scratch & Dent - Small / (R) Step, In-panel, Side Spoiler - Scratch & Dent - Small / (R) Rear Fender, Molding - Scratch & Dent - Small / Trunk Hood, Rear Gate - Scratch - Medium / Rear Bumper, Lamps, Panels - Scratch - Medium / (L) Rear Fender, Molding - Scratch & Dent - Minimal / (L) Rear Door, Molding - Scratch & Dent - Small / (L) Front Door, Molding - Scratch & Dent - Small / (L) Step, In-panel, Side Spoiler - Scratch & Dent - Minimal / (L) Front Fender, Molding - Scratch & Dent - Minimal / Roof - Scratch & Dent - Small / Bonnet, Headlight - Scratch - Medium / Front Bumper, Grille, Lamps - Scratch & Dent - Small
