## General Information

<b>Make</b>	Toyota	<b>Model</b>	Vios
<b>YOM</b>	2020	<b>Odo Meter Reading</b>	56,840
<b>Registration No.</b>	NGM1829	<b>Chassis No.</b>	PA1B18F33L4115960
<b>CC</b>	1.3	<b>Transmission</b>	M/T
<b>Fuel Type</b>	Gas	<b>Type of Body</b>	Sedan
<b>Colour</b>	Silver

## Body / Panel Condition

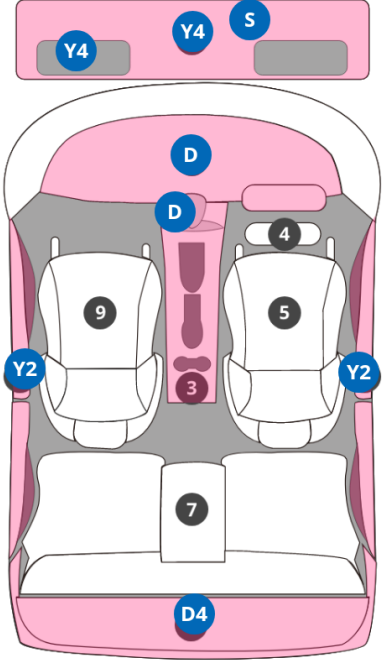
<p><b>A</b> : Scratch <b>AU</b> : Scratch &amp; Dent <b>B</b> : Modified <b>C</b> : Corrosion <b>G</b> : Stone chip <b>P</b> : Faded <b>S</b> : Rust <b>SC</b> : Rust &amp; Corrosion <b>U</b> : Dent <b>X</b> : Defective <b>Y</b> : Crack, Gap</p>
<p><b>Remarks</b> Ceiling - Grime - Large / Sunvisor, Sunglass Holder - Grime - Large / (R) Front Trim - Grime - Small / Dashboard - Traces of Adhesive Tape - Yes / Trunk Room - Worked - Large / (L) Front Trim - Grime - Small / Overall Interior - Smell - Yes / Console, Switches, Vents - Traces of Adhesive Tape - Yes</p>	<p><b>Remarks</b> (R) Front Fender - Repair Traces - Yes / (L) Front Fender - Repair Traces - Yes / (L) Front Door - Repair Traces - Yes / (L) Front Fender, Molding - Scratch - Minimal / (L) Mirror - Scratch - Small / (L) Front Door, Molding - Scratch - Medium / Bonnet, Headlight - Scratch - Small / Member (Bolted) - Dent - Yes / Front Bumper, Grille, Lamps - Scratch - Medium / (L) Rear Door, Molding - Dent - Small / (L) Rear Fender, Molding - Scratch - Small / Trunk Hood, Rear Gate - Scratch - Small / Rear Bumper, Lamps, Panels - Scratch - Medium / (R) Rear Fender, Molding - Scratch - Small / (R) Mirror - Scratch - Small / (R) Front Door, Molding - Scratch &amp; Dent - Small / (R) Rear Door, Molding - Scratch - Small / (R) Front Fender, Molding - Scratch - Small / Roof - Dent - Small</p>
