General Information

Make	Mitsubishi	Model	L300
YOM	2018	Odo Meter Reading	114,998
Registration No.	NBP1148	Chassis No.	PAEL65NYHJB007654
CC	2.5	Transmission	M/T
Fuel Type	Diesel	Type of Body	Utility Vehicle
Colour	White

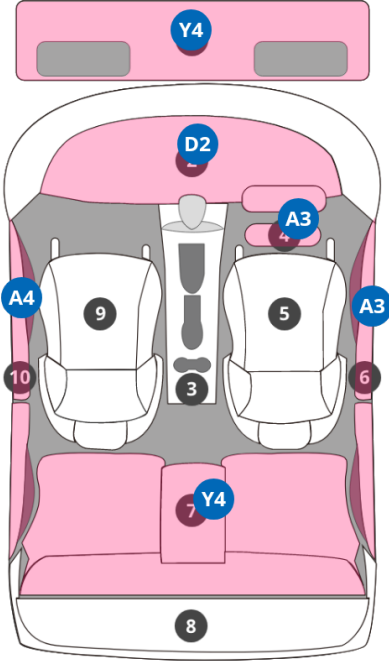
Interior Evaluation : C	Exterior Evaluation : E

<p>a : Cut, Fray d : Loose, Deformed k : Animal Hair s : Smell t : Cigarette Burns x : Defective y : Stain</p>

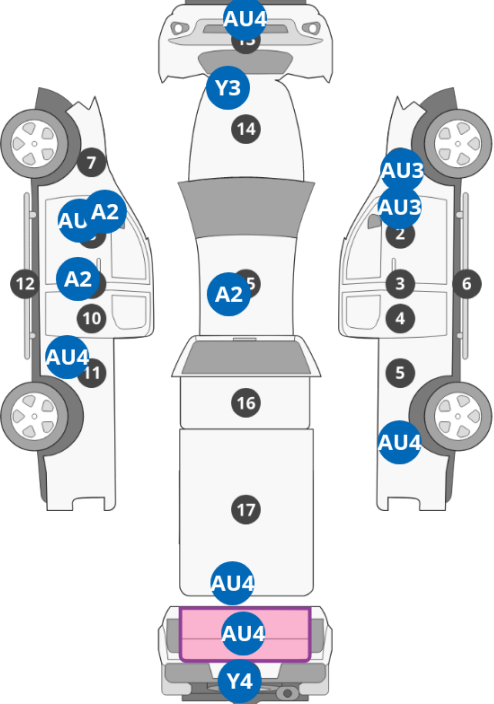
<p>A : Scratch AU : Scratch & Dent B : Modified C : Corrosion G : Stone chip P : Faded S : Rust SC : Rust & Corrosion U : Dent X : Defective Y : Crack, Gap</p>
<p>Remarks Ceiling - Grime - Large / Glove Box - Loose, Deformed - Small / (L) Front Trim - Cut, Crack - Large / (R) Front Trim - Cut, Crack - Medium / Carpet - Worn, Scratch, Cut, Crack - Medium / Overall Interior - Worn as per age - Yes / Rear Seat - Grime - Large</p>	<p>Remarks (L) Rear Corner Panel - Repair Traces - Yes / (R) Front Fender, Molding - Scratch & Dent - Medium / (R) Front Door, Molding - Scratch & Dent - Medium / (R) Side Gate - Scratch & Dent - Large / Rear Gate - Scratch & Dent - Large / Rear Gate - Repair mark - Yes / Rear Bumper, Lamps, Panels - Crack, Gap - Large / Roof - Scratch & Dent - Large / (L) Side Gate - Scratch & Dent - Large / (L) Front Door, Molding - Scratch & Dent - Medium / (L) Mirror - Scratch - Small / Cargo Bed Floor - Scratch - Small / Front Bumper, Grille, Lamps - Scratch & Dent - Large / Bonnet, Headlight - Crack, Gap - Medium / (L) Center Panel - Scratch - Small / Overall Exterior - Re-Paint Uneven - Yes</p>
