## General Information

Date & Time: 15, Jan, 2026 05:52

<b>Make</b>	Toyota	<b>Model</b>	Hilux Tamaraw
<b>YOM</b>	2025	<b>Odo Meter Reading</b>	4,459
<b>Registration No.</b>	FAT4031	<b>Chassis No.</b>	PAHAD9DAS1627721
<b>CC</b>	2.4	<b>Transmission</b>	A/T
<b>Fuel Type</b>	Diesel	<b>Type of Body</b>	Dropside
<b>Colour</b>	Black

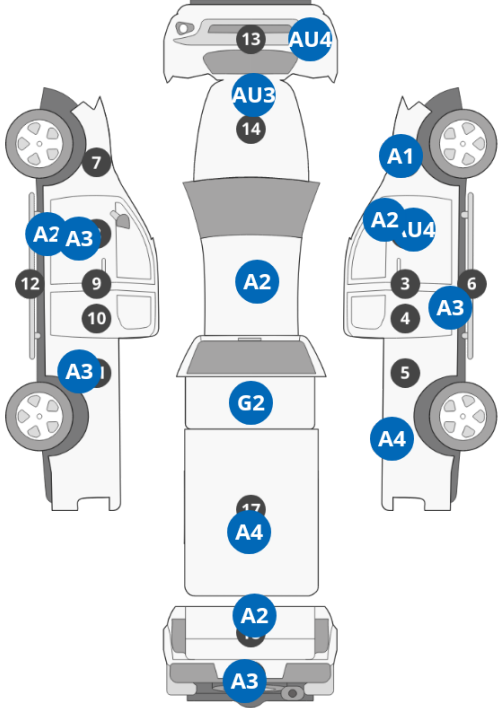
<p><b>A</b> : Scratch <b>AU</b> : Scratch &amp; Dent <b>B</b> : Modified <b>C</b> : Corrosion <b>G</b> : Stone chip <b>P</b> : Faded <b>S</b> : Rust <b>SC</b> : Rust &amp; Corrosion <b>U</b> : Dent <b>X</b> : Defective <b>Y</b> : Crack, Gap</p>
<p><b>Remarks</b> (R) Front Seat - Grime - Large / Dashboard - Worn, Scratch, Cut, Crack - Medium / Console, Switches, Vents - Worn, Scratch, Cut, Crack - Small / (R) Front Trim - Grime - Medium / Rear Seat - Grime - Medium / (L) Front Seat - Grime - Small / Ceiling - Grime - Small</p>	<p><b>Remarks</b> (L) Step, In-panel, Side Spoiler - Scratch - Small / (L) Front Door, Molding - Scratch - Medium / (L) Guard Frame - Scratch - Medium / Cargo Bed Floor - Scratch - Large / Rear Gate - Scratch - Small / Rear Bumper, Lamps, Panels - Scratch - Medium / (R) Guard Frame - Scratch - Large / (R) Rear Corner Panel - Scratch - Medium / (R) Front Door, Molding - Scratch &amp; Dent - Large / (R) Mirror - Scratch - Small / (R) Front Fender, Molding - Scratch - Minimal / Front Bumper, Grille, Lamps - Scratch &amp; Dent - Large / Bonnet, Headlight - Scratch &amp; Dent - Medium / Roof - Scratch - Small / Rear Windshield - Scratch, Stone chip - Small</p>
