## General Information

<b>Make</b>	Toyota	<b>Model</b>	Avanza
<b>YOM</b>	2024	<b>Odo Meter Reading</b>	28,644
<b>Registration No.</b>	FAQ8372	<b>Chassis No.</b>	MHFAA1BY4R0028489
<b>CC</b>	1.3	<b>Transmission</b>	CVT
<b>Fuel Type</b>	Gas	<b>Type of Body</b>	MPV
<b>Colour</b>	Green

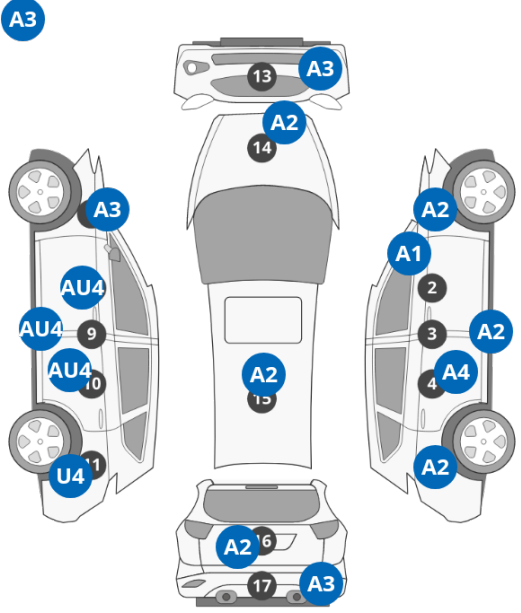
<p><b>A</b> : Scratch <b>AU</b> : Scratch &amp; Dent <b>B</b> : Modified <b>C</b> : Corrosion <b>G</b> : Stone chip <b>P</b> : Faded <b>S</b> : Rust <b>SC</b> : Rust &amp; Corrosion <b>U</b> : Dent <b>X</b> : Defective <b>Y</b> : Crack, Gap</p>
<b>Remarks</b> (L) Front Seat - Grime - Medium / (L) Front Trim - Grime - Medium / (L) Rear Trim - Grime - Medium / Trunk Room - Worn, Scratch, Cut, Crack - Medium / Rear Seat - Grime - Large / (R) Rear Trim - Grime - Large / (R) Front Seat - Grime - Large / (R) Front Floor Mat - Grime - Medium / Dashboard - Worn, Scratch, Cut, Crack - Medium / Ceiling - Grime - Small / Console, Switches, Vents - Worn, Scratch, Cut, Crack - Medium	<b>Remarks</b> Trunk Hood, Rear Gate - Scratch - Small / Rear Bumper, Lamps, Panels - Scratch - Medium / (R) Rear Fender, Molding - Scratch - Small / (R) Rear Door, Molding - Scratch - Large / (R) Front Door, Molding - Scratch - Medium / (R) Step, In-panel, Side Spoiler - Scratch - Small / (R) Mirror - Scratch - Minimal / (R) Front Fender, Molding - Scratch - Small / Bonnet, Headlight - Scratch - Small / Front Bumper, Grille, Lamps - Scratch - Medium / (L) Front Fender, Molding - Scratch - Medium / (L) Front Door, Molding - Scratch & Dent - Large / (L) Step, In-panel, Side Spoiler - Scratch & Dent - Large / (L) Rear Door, Molding - Scratch & Dent - Large / (L) Rear Fender, Molding - Dent - Large / Roof - Scratch - Small
