## General Information

<b>Make</b>	Mitsubishi	<b>Model</b>	Mirage
<b>YOM</b>	2023	<b>Odo Meter Reading</b>	49,688
<b>Registration No.</b>	CCA1384	<b>Chassis No.</b>	PAEA13TJPPA008210
<b>CC</b>	1.2	<b>Transmission</b>	CVT
<b>Fuel Type</b>	Gas	<b>Type of Body</b>	Sedan
<b>Colour</b>	Red

## Body / Panel Condition

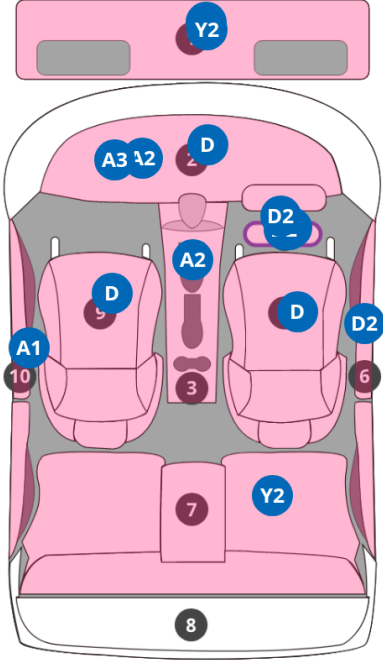
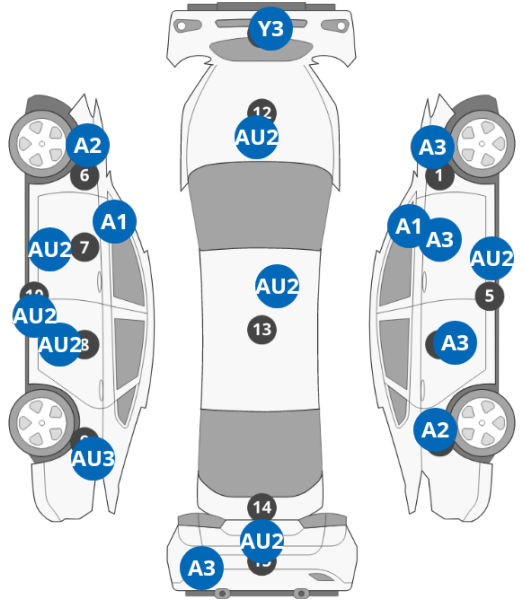
<b>Interior Evaluation :</b>	<b>D</b>	<b>Exterior Evaluation :</b>	<b>E</b>

<p><b>a</b> : Cut, Fray <b>d</b> : Loose, Deformed <b>k</b> : Animal Hair <b>s</b> : Smell <b>t</b> : Cigarette Burns <b>x</b> : Defective <b>y</b> : Stain</p>		<p><b>A</b> : Scratch <b>AU</b> : Scratch &amp; Dent <b>B</b> : Modified <b>C</b> : Corrosion <b>G</b> : Stone chip <b>P</b> : Faded <b>S</b> : Rust <b>SC</b> : Rust &amp; Corrosion <b>U</b> : Dent <b>X</b> : Defective <b>Y</b> : Crack, Gap</p>	
<p><b>Remarks</b> (L) Front Seat - Worn - Yes / (R) Front Seat - Worn - Yes / Rear Seat - Grime - Small / (L) Front Floor Mat - Worked - Small / (L) Front Floor Mat - Missing - Yes / (R) Front Floor Mat - Worked - Small / Mat Other - Worked - Small / (L) Front Trim - Cut, Crack - Minimal / (R) Front Trim - Worked - Small / Dashboard - Traces of Adhesive Tape - Yes / Console, Switches, Vents - Worn, Scratch, Cut, Crack - Small / Dashboard - Worn, Scratch, Cut, Crack - Small / Steering Wheel - Worn, Peel, Crack - Medium / Overall Interior - Smell - Yes / Ceiling - Grime - Small</p>		<p><b>Remarks</b> Front Bumper, Grille, Lamps - Crack, Gap - Medium / (R) Front Fender, Molding - Scratch - Medium / (R) Front Door, Molding - Scratch - Medium / (R) Rear Door, Molding - Scratch - Medium / (R) Step, In-panel, Side Spoiler - Scratch &amp; Dent - Small / (R) Rear Fender, Molding - Scratch - Small / Trunk Hood, Rear Gate - Scratch &amp; Dent - Small / Rear Bumper, Lamps, Panels - Scratch - Medium / (L) Rear Fender, Molding - Scratch &amp; Dent - Medium / (L) Rear Door, Molding - Scratch &amp; Dent - Small / (L) Front Door, Molding - Scratch &amp; Dent - Small / (L) Step, In-panel, Side Spoiler - Scratch &amp; Dent - Small / (L) Front Fender, Molding - Scratch - Small / (L) Mirror - Scratch - Minimal / (R) Mirror - Scratch - Minimal / Bonnet, Headlight - Scratch &amp; Dent - Small / Roof - Scratch &amp; Dent - Small</p>
