## General Information

Date & Time: 12, Dec, 2025 10:14

<b>Make</b>	Suzuki	<b>Model</b>	Dzire
<b>YOM</b>	2023	<b>Odo Meter Reading</b>	27,501
<b>Registration No.</b>	NIP6784	<b>Chassis No.</b>	MBHZF63S8RG369080
<b>CC</b>	1.2	<b>Transmission</b>	A/T
<b>Fuel Type</b>	Gas	<b>Type of Body</b>	Sedan
<b>Colour</b>	Gray

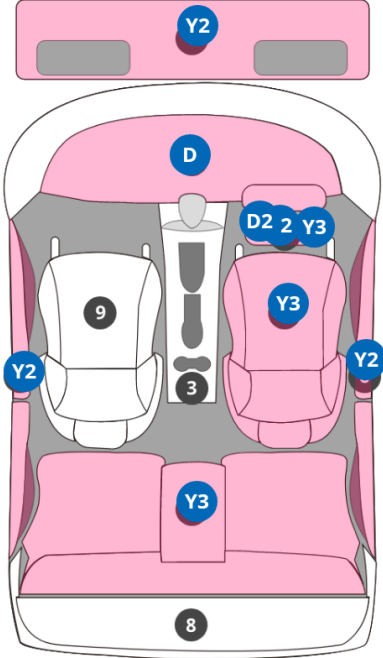
<b>Interior Evaluation :</b> <span style="float: right; color: red; font-weight: bold;">C</span>	<b>Exterior Evaluation :</b> <span style="float: right; color: red; font-weight: bold;">D</span>

<p><b>a</b> : Cut, Fray <b>d</b> : Loose, Deformed <b>k</b> : Animal Hair <b>s</b> : Smell <b>t</b> : Cigarette Burns <b>x</b> : Defective <b>y</b> : Stain</p>

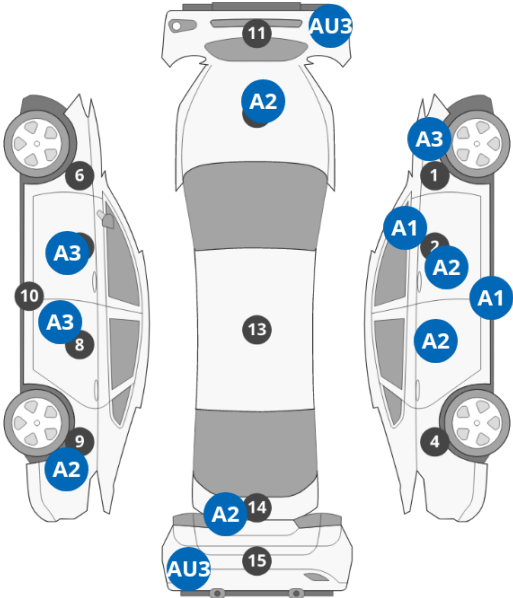
<p><b>A</b> : Scratch <b>AU</b> : Scratch &amp; Dent <b>B</b> : Modified <b>C</b> : Corrosion <b>G</b> : Stone chip <b>P</b> : Faded <b>S</b> : Rust <b>SC</b> : Rust &amp; Corrosion <b>U</b> : Dent <b>X</b> : Defective <b>Y</b> : Crack, Gap</p>
<p><b>Remarks</b> Ceiling - Grime - Small / Dashboard - Traces of Adhesive Tape - Yes / (R) Front Floor Mat - Grime - Medium / (R) Front Seat - Grime - Medium / (R) Front Trim - Grime - Small / Rear Seat - Grime - Medium / Mat Other - Grime - Small / (L) Front Trim - Grime - Small / (L) Front Floor Mat - Worked - Small</p>	<p><b>Remarks</b> (R) Front Door - Repair Traces - Yes / (L) Front Door, Molding - Scratch - Medium / (L) Rear Door, Molding - Scratch - Medium / (R) Front Fender, Molding - Scratch - Medium / (L) Rear Fender, Molding - Scratch - Small / Trunk Hood, Rear Gate - Scratch - Small / Rear Bumper, Lamps, Panels - Scratch &amp; Dent - Medium / (R) Rear Door, Molding - Scratch - Small / (R) Front Door, Molding - Scratch - Small / (R) Step, In-panel, Side Spoiler - Scratch - Minimal / (R) Mirror - Scratch - Minimal / Bonnet, Headlight - Scratch - Small / Front Bumper, Grille, Lamps - Scratch &amp; Dent - Medium</p>
