## General Information

<b>Make</b>	Mitsubishi	<b>Model</b>	Mirage
<b>YOM</b>	2018	<b>Odo Meter Reading</b>	55,121
<b>Registration No.</b>	NBP8322	<b>Chassis No.</b>	PAEA23TJJA003934
<b>CC</b>	1.2	<b>Transmission</b>	A/T
<b>Fuel Type</b>	Gas	<b>Type of Body</b>	Sedan
<b>Colour</b>	Red

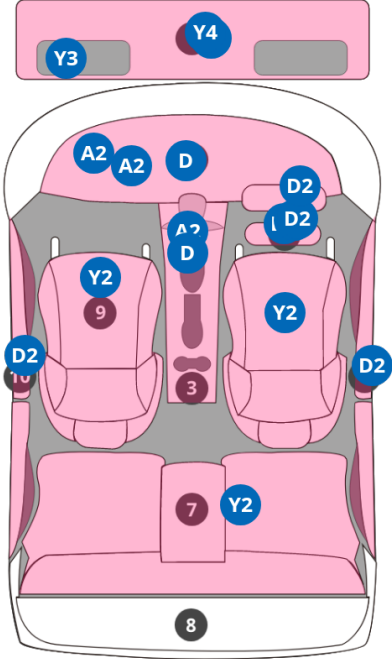
<p><b>a</b> : Cut, Fray <b>d</b> : Loose, Deformed <b>k</b> : Animal Hair <b>s</b> : Smell <b>t</b> : Cigarette Burns <b>x</b> : Defective <b>y</b> : Stain</p>

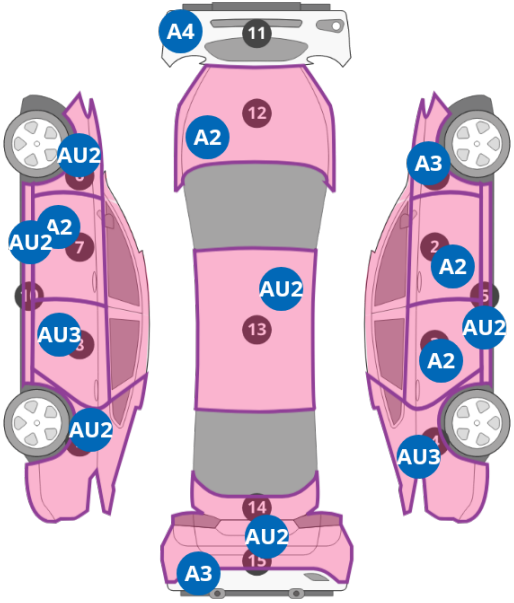
<p><b>A</b> : Scratch <b>AU</b> : Scratch &amp; Dent <b>B</b> : Modified <b>C</b> : Corrosion <b>G</b> : Stone chip <b>P</b> : Faded <b>S</b> : Rust <b>SC</b> : Rust &amp; Corrosion <b>U</b> : Dent <b>X</b> : Defective <b>Y</b> : Crack, Gap</p>
<p><b>Remarks</b></p> <p>Overall Interior - Smell - Yes / Overall Interior - Worn as per age - Yes / Ceiling - Grime - Large / Sunvisor, Sunglass Holder - Grime - Medium / (L) Front Floor Mat - Worked - Small / (L) Front Trim - Worked - Small / (R) Front Trim - Worked - Small / (R) Front Floor Mat - Worked - Small / Mat Other - Worked - Small / (L) Front Seat - Grime - Small / (R) Front Seat - Grime - Small / Rear Seat - Grime - Small / Console, Switches, Vents - Worn, Scratch, Cut, Crack - Small / Console, Switches, Vents - Traces of Adhesive Tape - Yes / Dashboard - Worn, Scratch, Cut, Crack - Small / Steering Wheel - Worn, Peel, Crack - Small / Glove Box - Loose, Deformed - Small</p>	<p><b>Remarks</b></p> <p>(R) Front Door - Repair Traces - Yes / (R) Step - Repair Traces - Yes / (R) Front Fender - Repair Traces - Yes / Bonnet - Repair Traces - Yes / (L) Front Fender - Repair Traces - Yes / (L) Front Door - Repair Traces - Yes / (L) Step - Repair Traces - Yes / (L) Rear Door - Repair Traces - Yes / (L) Rear Fender - Repair Traces - Yes / Trunk Hood, Rear Gate - Repair Traces - Yes / (R) Rear Fender - Repair Traces - Yes / (R) Rear Fender - Replaced - Yes / (R) Rear Door - Repair Traces - Yes / Roof - Repair Traces - Yes / (L) Rear Fender, Molding - Repair mark - Yes / (L) Rear Door, Molding - Repair mark - Yes / (L) Front Door, Molding - Repair mark - Yes / (L) Step, In-panel, Side Spoiler - Repair mark - Yes / (L) Front Fender, Molding - Repair mark - Yes / Bonnet, Headlight - Repair mark - Yes / (R) Front Fender, Molding - Repair mark - Yes / (R) Front Door, Molding - Repair mark - Yes / (R) Rear Door, Molding - Repair mark - Yes / (R) Step, In-panel, Side Spoiler - Repair mark - Yes / Roof - Repair mark - Yes / Trunk Hood, Rear Gate - Repair mark - Yes / Front Bumper, Grille, Lamps - Scratch - Large / (L) Front Fender, Molding - Scratch &amp; Dent - Small / (L) Front Door, Molding - Scratch - Small / (L) Rear Door, Molding - Scratch &amp; Dent - Medium / (L) Rear Fender, Molding - Scratch &amp; Dent - Small / Rear Bumper, Lamps, Panels - Scratch - Medium / Trunk Hood, Rear Gate - Scratch &amp; Dent - Small / (R) Rear Fender, Molding - Scratch &amp; Dent - Medium / (R) Rear Door, Molding - Scratch - Small / (R) Front Door, Molding - Scratch - Small / (R) Step, In-panel, Side Spoiler - Scratch &amp; Dent - Small / (R) Front Fender, Molding - Scratch - Medium / Bonnet, Headlight - Scratch - Small / Roof - Scratch &amp; Dent - Small / (L) Step, In-panel, Side Spoiler - Scratch &amp; Dent - Small</p>
