## General Information

| Make | Mitsubishi | Model | L300 |
| Registration No. | DBP1853 | Chassis No. | PAEL65MYRRB021619 |

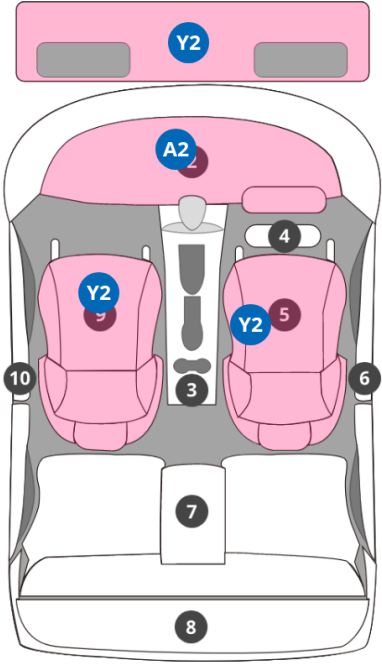
| Interior Evaluation : <b>A</b> | Exterior Evaluation : <b>C</b> |
|---|---|
| <p><b>Remarks</b><br/>Ceiling - Grime - Small / Dashboard - Worn, Scratch, Cut, Crack - Small / (R) Front Seat - Grime - Small / (L) Front Seat - Grime - Small</p> | <p><b>Remarks</b><br/>(L) Front Fender, Molding - Scratch - Small / Front Bumper, Grille, Lamps - Scratch - Small / (L) Front Door, Molding - Scratch - Minimal / (R) Front Door, Molding - Scratch - Minimal / Rear Bumper, Lamps, Panels - Scratch - Large / (R) Side Gate - Scratch - Medium / (L) Rear Wheel, Cover - Scratch, Corrosion - Small / (R) Rear Wheel, Cover - Scratch, Corrosion - Small / Roof - Scratch - Small / Front Panel - Scratch - Minimal / Cargo Bed Floor - Scratch - Medium</p> |
