General Information

Make	MG	Model	GT
YOM	2024	Odo Meter Reading	12,959
Registration No.	GBE9284	Chassis No.	LSJA36U94PN217649
CC	1.5	Transmission	A/T
Fuel Type	Gas	Type of Body	Sedan
Colour	White

Body / Panel Condition

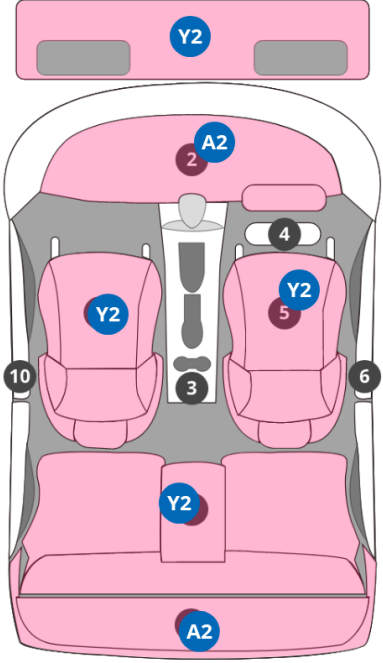
Interior Evaluation : B	Exterior Evaluation : E

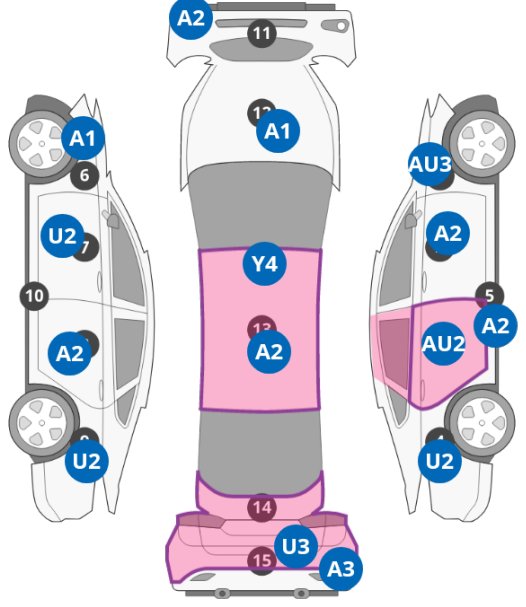
<p>A : Scratch AU : Scratch & Dent B : Modified C : Corrosion G : Stone chip P : Faded S : Rust SC : Rust & Corrosion U : Dent X : Defective Y : Crack, Gap</p>
<p>Remarks Rear Seat - Grime - Small / Trunk Room - Worn, Scratch, Cut, Crack - Small / Ceiling - Grime - Small / Dashboard - Worn, Scratch, Cut, Crack - Small / (L) Front Seat - Grime - Small / (R) Front Seat - Grime - Small</p>	<p>Remarks (R) Front Door - Repair Traces - Yes / (R) Front Fender - Repair Traces - Yes / Bonnet - Repair Traces - Yes / (L) Front Fender - Repair Traces - Yes / Trunk Hood, Rear Gate - Repair Traces - Yes / (R) Rear Door - Repair Traces - Yes / Roof - Repair Traces - Yes / Trunk Hood, Rear Gate - Repair mark - Yes / Roof - Repair mark - Yes / (R) Front Fender, Molding - Scratch & Dent - Medium / (R) Front Door, Molding - Scratch - Small / (R) Rear Door, Molding - Scratch & Dent - Small / (R) Step, In-panel, Side Spoiler - Scratch - Small / (R) Rear Fender, Molding - Dent - Small / Rear Bumper, Lamps, Panels - Scratch - Medium / (L) Rear Fender, Molding - Dent - Small / (L) Rear Door, Molding - Scratch - Small / (L) Front Door, Molding - Dent - Small / (L) Front Fender, Molding - Scratch - Minimal / (R) Rear Door, Molding - Repair mark - Yes / Front Bumper, Grille, Lamps - Scratch - Small / Bonnet, Headlight - Scratch - Minimal / Roof - Scratch - Small / Trunk Hood, Rear Gate - Dent - Medium / Front Windshield - Damaged - Large</p>
