General Information

Make	Toyota	Model	Avanza
YOM	2024	Odo Meter Reading	20,964
Registration No.	GBH2819	Chassis No.	MHFAA1BY8P0018559
CC	1.3	Transmission	CVT
Fuel Type	Gas	Type of Body	MPV
Colour	Silver

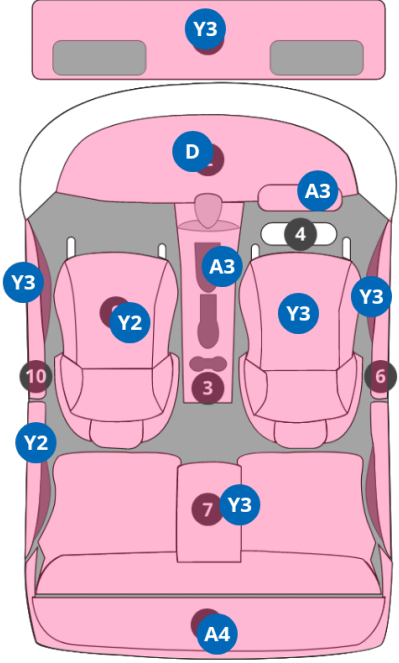
Interior Evaluation : E	Exterior Evaluation : E

<p>a : Cut, Fray d : Loose, Deformed k : Animal Hair s : Smell t : Cigarette Burns x : Defective y : Stain</p>

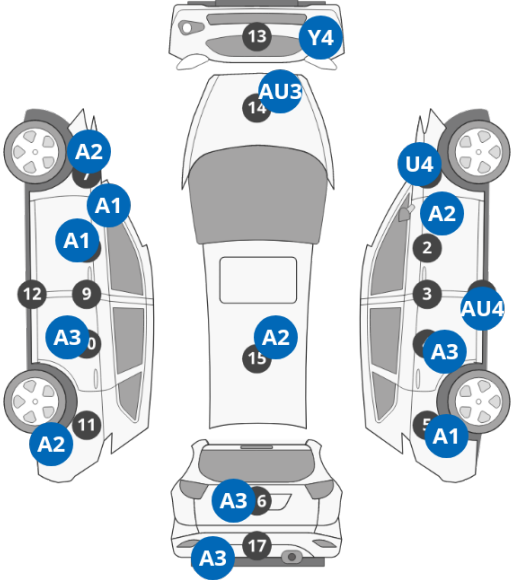
<p>A : Scratch AU : Scratch & Dent B : Modified C : Corrosion G : Stone chip P : Faded S : Rust SC : Rust & Corrosion U : Dent X : Defective Y : Crack, Gap</p>
<p>Remarks (R) Front Seat - Grime - Medium / (R) Front Trim - Grime - Medium / Rear Seat - Grime - Medium / Trunk Room - Worn, Scratch, Cut, Crack - Large / (L) Rear Trim - Grime - Small / (L) Front Trim - Grime - Medium / Steering Wheel - Worn, Peel, Crack - Medium / (L) Front Seat - Grime - Small / Console, Switches, Vents - Worn, Scratch, Cut, Crack - Medium / Ceiling - Grime - Medium / Dashboard - Traces of Adhesive Tape - Yes</p>	<p>Remarks (R) Front Door - Repair Traces - Yes / (R) Front Fender - Repair Traces - Yes / Bonnet - Repair Traces - Yes / (L) Front Fender - Repair Traces - Yes / (L) Mirror - Scratch - Minimal / (L) Front Fender, Molding - Scratch - Small / Bonnet, Headlight - Scratch & Dent - Medium / (R) Front Fender, Molding - Dent - Large / Front Bumper, Grille, Lamps - Crack, Gap - Large / (R) Front Door, Molding - Scratch - Small / (R) Step, In-panel, Side Spoiler - Scratch & Dent - Large / (R) Rear Door, Molding - Scratch - Medium / (R) Rear Fender, Molding - Scratch - Minimal / Rear Bumper, Lamps, Panels - Scratch - Medium / Trunk Hood, Rear Gate - Scratch - Medium / (L) Rear Fender, Molding - Scratch - Small / (L) Rear Door, Molding - Scratch - Medium / (L) Front Door, Molding - Scratch - Minimal / Roof - Scratch - Small</p>
