## General Information

<b>Make</b>	Toyota	<b>Model</b>	Hiace
<b>YOM</b>	2024	<b>Odo Meter Reading</b>	22,198
<b>Registration No.</b>	CCF2270	<b>Chassis No.</b>	JTFNAFAPXR8043154
<b>CC</b>	2.8	<b>Transmission</b>	M/T
<b>Fuel Type</b>	Diesel	<b>Type of Body</b>	Van
<b>Colour</b>	Silver

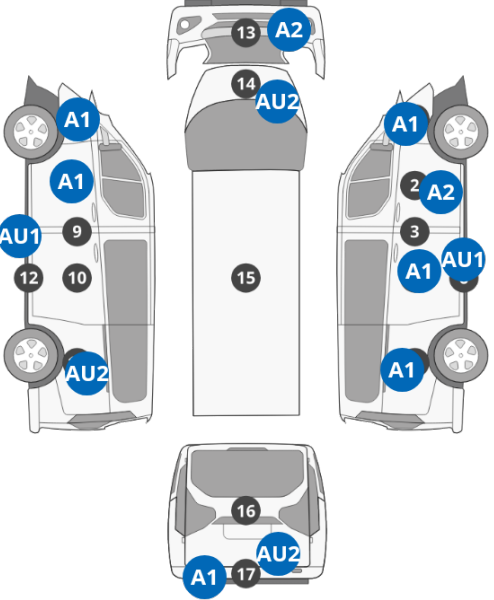
<p><b>A</b> : Scratch <b>AU</b> : Scratch &amp; Dent <b>B</b> : Modified <b>C</b> : Corrosion <b>G</b> : Stone chip <b>P</b> : Faded <b>S</b> : Rust <b>SC</b> : Rust &amp; Corrosion <b>U</b> : Dent <b>X</b> : Defective <b>Y</b> : Crack, Gap</p>
<p><b>Remarks</b> (L) Front Floor Mat - Worked - Small / Mat Other - Missing - Yes / Dashboard - Traces of Adhesive Tape - Yes / Dashboard - Worn, Scratch, Cut, Crack - Minimal / (L) Front Seat - Grime - Small / (R) Front Seat - Grime - Small / Overall Interior - Smell - Yes / Ceiling - Grime - Small</p>	<p><b>Remarks</b> (L) Front Fender, Molding - Scratch - Minimal / Bonnet, Headlight - Scratch &amp; Dent - Small / Front Bumper, Grille, Lamps - Scratch - Small / (R) Front Fender, Molding - Scratch - Minimal / (R) Front Door, Molding - Scratch - Small / (R) Rear Door, Molding - Scratch - Minimal / (R) Step, In-panel, Side Spoiler - Scratch &amp; Dent - Minimal / (R) Rear Fender, Molding - Scratch - Minimal / Trunk Hood, Rear Gate - Scratch &amp; Dent - Small / Rear Bumper, Lamps, Panels - Scratch - Minimal / (L) Rear Fender, Molding - Scratch &amp; Dent - Small / (L) Step, In-panel, Side Spoiler - Scratch &amp; Dent - Minimal / (L) Front Door, Molding - Scratch - Minimal</p>
