## General Information

<b>Make</b>	Mitsubishi	<b>Model</b>	Mirage
<b>YOM</b>	2025	<b>Odo Meter Reading</b>	13,958
<b>Registration No.</b>	NKM1826	<b>Chassis No.</b>	PAE13RJSRA004150
<b>CC</b>	1.2	<b>Transmission</b>	CVT
<b>Fuel Type</b>	Gas	<b>Type of Body</b>	Sedan
<b>Colour</b>	Gray

## Body / Panel Condition

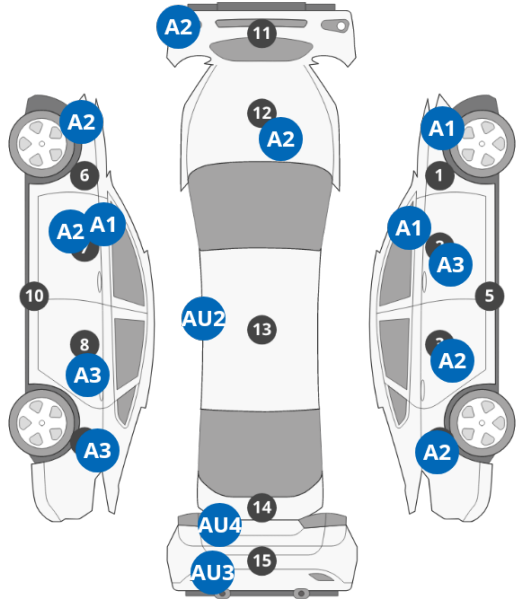
<p><b>A :</b> Scratch <b>AU :</b> Scratch &amp; Dent <b>B :</b> Modified <b>C :</b> Corrosion <b>G :</b> Stone chip <b>P :</b> Faded <b>S :</b> Rust <b>SC :</b> Rust &amp; Corrosion <b>U :</b> Dent <b>X :</b> Defective <b>Y :</b> Crack, Gap</p>
<p><b>Remarks</b> (L) Front Seat - Grime - Small / (R) Front Seat - Grime - Medium / Rear Seat - Grime - Small / Ceiling - Grime - Small / (R) Rear Trim - Cut, Crack - Minimal / (R) Front Floor Mat - Grime - Small / Dashboard - Traces of Adhesive Tape - Yes</p>	<p><b>Remarks</b> (R) Front Fender, Molding - Scratch - Minimal / (R) Mirror - Scratch - Minimal / (R) Front Door, Molding - Scratch - Medium / (R) Rear Door, Molding - Scratch - Small / (R) Rear Fender, Molding - Scratch - Small / Rear Bumper, Lamps, Panels - Scratch &amp; Dent - Medium / Trunk Hood, Rear Gate - Scratch &amp; Dent - Large / (L) Rear Fender, Molding - Scratch - Medium / (L) Rear Door, Molding - Scratch - Medium / (L) Front Door, Molding - Scratch - Small / (L) Mirror - Scratch - Minimal / (L) Front Fender, Molding - Scratch - Small / Front Bumper, Grille, Lamps - Scratch - Small / Bonnet, Headlight - Scratch - Small / Roof - Scratch &amp; Dent - Small</p>
