General Information

Make	Toyota	Model	Vios
YOM	2017	Odo Meter Reading	88,554
Registration No.	DAB5270	Chassis No.	PA1B19F32H4019881
CC	1.3	Transmission	A/T
Fuel Type	Gas	Type of Body	Sedan
Colour	Red Mica Metallic

Body / Panel Condition

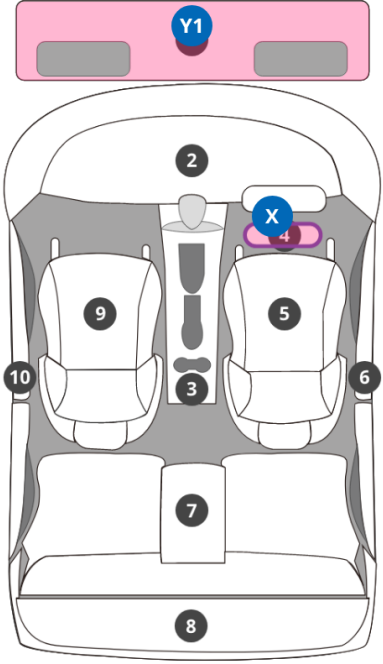
Interior Evaluation : B	Exterior Evaluation : E

<p>a : Cut, Fray d : Loose, Deformed k : Animal Hair s : Smell t : Cigarette Burns x : Defective y : Stain</p>

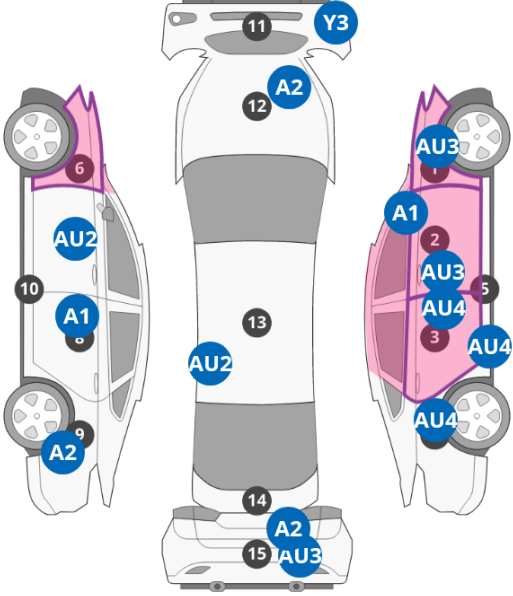
<p>A : Scratch AU : Scratch & Dent B : Modified C : Corrosion G : Stone chip P : Faded S : Rust SC : Rust & Corrosion U : Dent X : Defective Y : Crack, Gap</p>
Remarks Ceiling - Grime - Minimal / Mat Other - Missing - Yes	Remarks (R) Front Door - Repair Traces - Yes / (R) Step - Repair Traces - Yes / (R) Front Fender - Repair Traces - Yes / Bonnet - Repair Traces - Yes / (L) Front Fender - Repair Traces - Yes / (L) Front Door - Repair Traces - Yes / (L) Step - Repair Traces - Yes / (L) Rear Door - Repair Traces - Yes / (L) Rear Fender - Repair Traces - Yes / Trunk Hood, Rear Gate - Repair Traces - Yes / (R) Rear Fender - Repair Traces - Yes / (R) Rear Door - Repair Traces - Yes / Roof - Repair Traces - Yes / (R) Front Fender, Molding - Scratch & Dent - Medium / (R) Front Door, Molding - Scratch & Dent - Medium / (R) Rear Door, Molding - Scratch & Dent - Large / (R) Rear Fender, Molding - Scratch & Dent - Large / Rear Bumper, Lamps, Panels - Scratch & Dent - Medium / Trunk Hood, Rear Gate - Scratch - Small / Roof - Scratch & Dent - Small / (L) Rear Fender, Molding - Scratch - Small / (L) Rear Door, Molding - Scratch - Minimal / (L) Front Door, Molding - Scratch & Dent - Small / (L) Front Fender, Molding - Repair mark - Difference in Color / (R) Front Door, Molding - Repair mark - Difference in Color / (R) Rear Door, Molding - Repair mark - Difference in Color / (R) Front Fender, Molding - Repair mark - Difference in Color / (R) Mirror - Scratch - Minimal / Bonnet, Headlight - Scratch - Small / Front Bumper, Grille, Lamps - Crack, Gap - Medium / (R) Step, In-panel, Side Spoiler - Scratch & Dent - Large
