General Information

Date & Time: 15, Dec, 2025 14:01

Make	Mitsubishi	Model	Mirage
YOM	2019	Odo Meter Reading	78,837
Registration No.	DAN5700	Chassis No.	PAEA13TJKKA012655
CC	1.2	Transmission	A/T
Fuel Type	Gas	Type of Body	Sedan
Colour	Gray

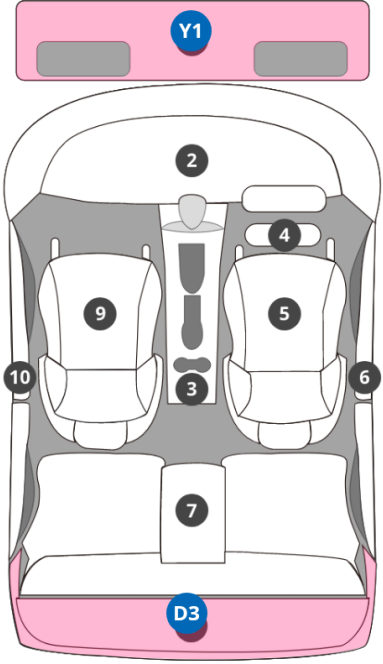
Interior Evaluation : B	Exterior Evaluation : D

<p>a : Cut, Fray d : Loose, Deformed k : Animal Hair s : Smell t : Cigarette Burns x : Defective y : Stain</p>

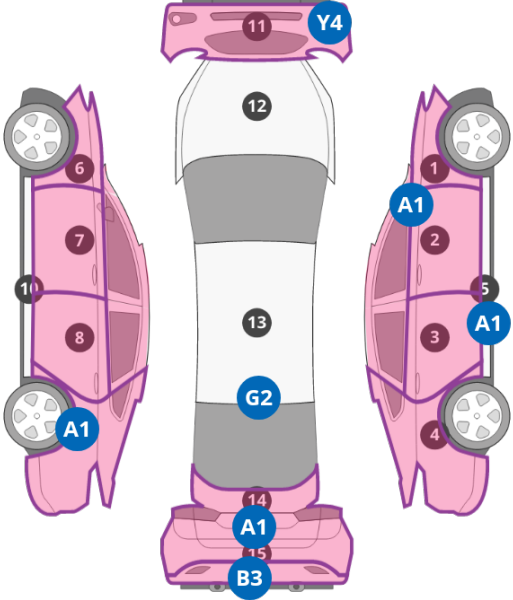
<p>A : Scratch AU : Scratch & Dent B : Modified C : Corrosion G : Stone chip P : Faded S : Rust SC : Rust & Corrosion U : Dent X : Defective Y : Crack, Gap</p>
Remarks Ceiling - Grime - Minimal / Trunk Room - Loose, Deformed - Medium	Remarks (R) Front Door - Repair Traces - Yes / (R) Front Fender - Repair Traces - Yes / Bonnet - Repair Traces - Yes / (L) Front Fender - Repair Traces - Yes / (L) Front Door - Repair Traces - Yes / (L) Rear Door - Repair Traces - Yes / (L) Rear Fender - Repair Traces - Yes / Trunk Hood, Rear Gate - Repair Traces - Yes / (R) Rear Fender - Repair Traces - Yes / (R) Rear Door - Repair Traces - Yes / Roof - Repair Traces - Yes / Overall Exterior - Full Re-Paint in same color - Yes / (R) Mirror - Scratch - Minimal / (R) Step, In-panel, Side Spoiler - Scratch - Minimal / Trunk Hood, Rear Gate - Scratch - Minimal / (L) Rear Fender, Molding - Scratch - Minimal / Rear Bumper, Lamps, Panels - Modified - Medium / (R) Front Door, Molding - Repair mark - Yes / (R) Rear Door, Molding - Repair mark - Yes / (R) Rear Fender, Molding - Repair mark - Yes / Trunk Hood, Rear Gate - Repair mark - Yes / (L) Rear Fender, Molding - Repair mark - Yes / (L) Front Door, Molding - Repair mark - Yes / (L) Front Fender, Molding - Repair mark - Yes / Front Bumper, Grille, Lamps - Repair mark - Yes / Front Bumper, Grille, Lamps - Crack, Gap - Large / Rear Bumper, Lamps, Panels - Repair mark - Yes / (L) Rear Door, Molding - Repair mark - Yes / Rear Windshield - Scratch, Stone chip - Small / (R) Front Fender, Molding - Repair mark - Yes
