General Information

Make	MG	Model	ZS
YOM	2020	Odo Meter Reading	73,183
Registration No.	LAI2608	Chassis No.	LSJW74U32LZ022145
CC	1.5	Transmission	M/T
Fuel Type	Gas	Type of Body	SUV
Colour	Red

Body / Panel Condition

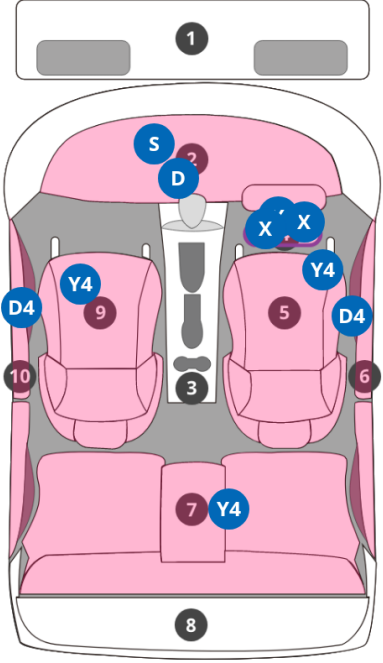
Interior Evaluation : D	Exterior Evaluation : E

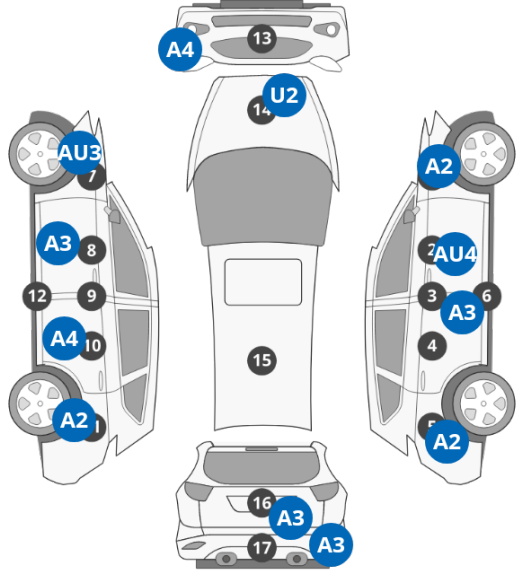
<p>A : Scratch AU : Scratch & Dent B : Modified C : Corrosion G : Stone chip P : Faded S : Rust SC : Rust & Corrosion U : Dent X : Defective Y : Crack, Gap</p>
<p>Remarks Rear Seat - Grime - Large / (L) Front Floor Mat - Missing - Yes / (R) Front Floor Mat - Missing - Yes / Mat Other - Missing - Yes / (R) Front Seat - Grime - Large / (L) Front Seat - Grime - Large / Dashboard - Traces of Adhesive Tape - Yes / (L) Front Trim - Worked - Large / (R) Front Trim - Worked - Large / Overall Interior - Smell - Yes</p>	<p>Remarks Bonnet, Headlight - Dent - Small / (R) Rear Door, Molding - Scratch - Medium / (R) Front Door, Molding - Scratch & Dent - Large / Rear Bumper, Lamps, Panels - Scratch - Medium / Trunk Hood, Rear Gate - Scratch - Medium / (L) Rear Door, Molding - Scratch - Large / (L) Front Door, Molding - Scratch - Medium / (L) Front Fender, Molding - Scratch & Dent - Medium / Front Bumper, Grille, Lamps - Scratch - Large / (L) Rear Fender, Molding - Scratch - Small / (R) Rear Fender, Molding - Scratch - Small / (R) Front Fender, Molding - Scratch - Small</p>
