## General Information

Date & Time: 20, Dec, 2025 13:16

<b>Make</b>	Suzuki	<b>Model</b>	APV
<b>YOM</b>	2025	<b>Odo Meter Reading</b>	3,742
<b>Registration No.</b>	LAQ1603	<b>Chassis No.</b>	MHYDN71V9SJ400783
<b>CC</b>	1.6	<b>Transmission</b>	M/T
<b>Fuel Type</b>	Gas	<b>Type of Body</b>	Van
<b>Colour</b>	Silver

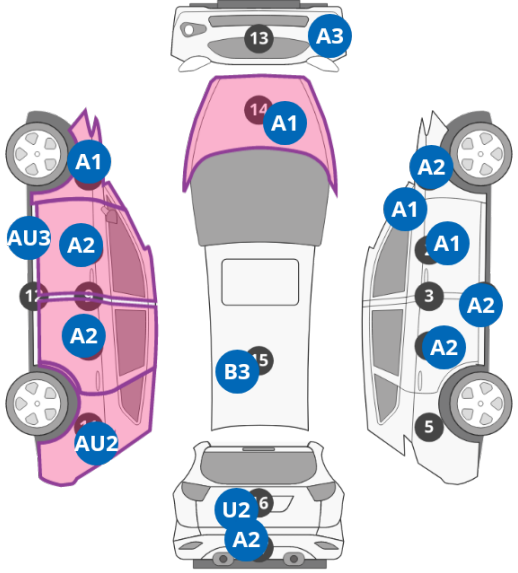
<p><b>A</b> : Scratch <b>AU</b> : Scratch &amp; Dent <b>B</b> : Modified <b>C</b> : Corrosion <b>G</b> : Stone chip <b>P</b> : Faded <b>S</b> : Rust <b>SC</b> : Rust &amp; Corrosion <b>U</b> : Dent <b>X</b> : Defective <b>Y</b> : Crack, Gap</p>
<p><b>Remarks</b> (R) Front Seat - Grime - Medium / (R) Front Trim - Grime - Medium / (R) Rear Trim - Grime - Large / Rear Seat - Grime - Medium / (L) Rear Trim - Grime - Large / (L) Front Trim - Grime - Large / (L) Front Seat - Grime - Minimal / Ceiling - Grime - Medium / Dashboard - Worn, Scratch, Cut, Crack - Small / Trunk Room - Worn, Scratch, Cut, Crack - Small</p>	<p><b>Remarks</b> (R) Front Door - Repair Traces - Yes / (R) Front Fender - Repair Traces - Yes / Bonnet - Repair Traces - Yes / (L) Front Fender - Repair Traces - Yes / (L) Front Door - Repair Traces - Yes / (L) Rear Door - Repair Traces - Yes / (L) Rear Fender - Repair Traces - Yes / Trunk Hood, Rear Gate - Repair Traces - Yes / (R) Rear Fender - Repair Traces - Yes / (R) Rear Door - Repair Traces - Yes / Roof - Repair Traces - Yes / (L) Front Fender, Molding - Repair mark - Yes / (L) Front Door, Molding - Repair mark - Yes / (L) Rear Door, Molding - Repair mark - Yes / (L) Rear Fender, Molding - Repair mark - Yes / Bonnet, Headlight - Repair mark - Yes / (R) Front Fender, Molding - Scratch - Small / (L) Front Fender, Molding - Scratch - Minimal / (L) Step, In-panel, Side Spoiler - Scratch &amp; Dent - Medium / Bonnet, Headlight - Scratch - Minimal / Front Bumper, Grille, Lamps - Scratch - Medium / (R) Mirror - Scratch - Minimal / (R) Front Door, Molding - Scratch - Minimal / (R) Rear Door, Molding - Scratch - Small / (R) Step, In-panel, Side Spoiler - Scratch - Small / Trunk Hood, Rear Gate - Dent - Small / Rear Bumper, Lamps, Panels - Scratch - Small / (L) Rear Fender, Molding - Scratch &amp; Dent - Small / (L) Rear Door, Molding - Scratch - Small / (L) Front Door, Molding - Scratch - Small / Roof - Modified - Medium</p>
