## General Information

<b>Make</b>	Mitsubishi	<b>Model</b>	L300
<b>YOM</b>	2025	<b>Odo Meter Reading</b>	5,847
<b>Registration No.</b>	NHH2432	<b>Chassis No.</b>	PAEL65NYSSB001157
<b>CC</b>	2.2	<b>Transmission</b>	M/T
<b>Fuel Type</b>	Diesel	<b>Type of Body</b>	FB Body
<b>Colour</b>	White

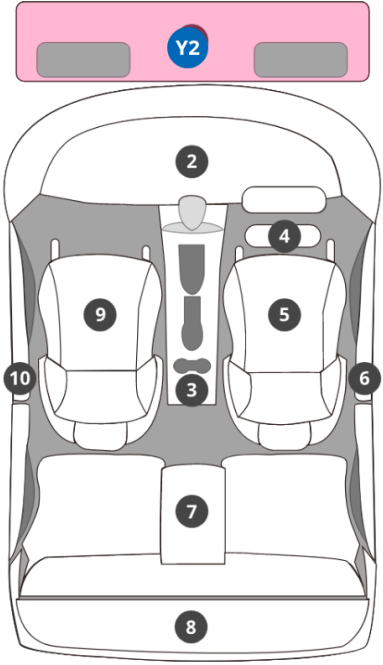
<b>Interior Evaluation :</b> <span style="color: red; font-weight: bold; font-size: 1.2em;">A</span>	<b>Exterior Evaluation :</b> <span style="color: red; font-weight: bold; font-size: 1.2em;">B</span>

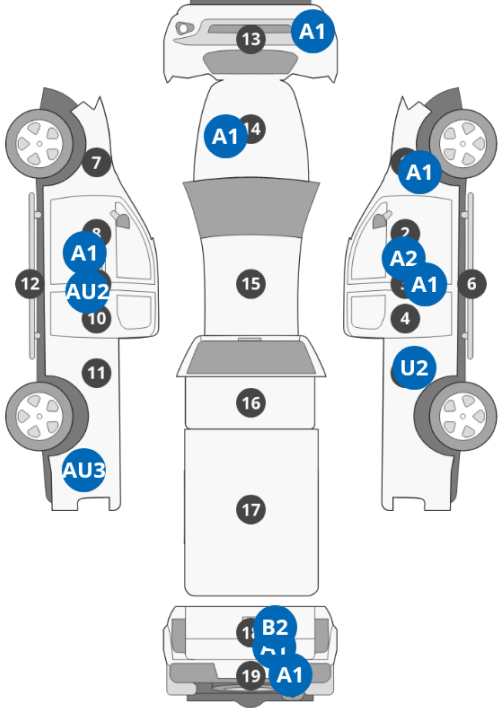
<p><b>A</b> : Scratch <b>AU</b> : Scratch &amp; Dent <b>B</b> : Modified <b>C</b> : Corrosion <b>G</b> : Stone chip <b>P</b> : Faded <b>S</b> : Rust <b>SC</b> : Rust &amp; Corrosion <b>U</b> : Dent <b>X</b> : Defective <b>Y</b> : Crack, Gap</p>
<b>Remarks</b> Ceiling - Grime - Small	<b>Remarks</b> (L) Rear Corner Panel - Repair Traces - Yes / (R) Rear Corner Panel - Repair Traces - Yes / (R) Front Fender, Molding - Scratch - Minimal / (R) Front Door, Molding - Scratch - Small / (R) Center Panel - Scratch - Minimal / (R) Side Gate - Dent - Small / Rear Bumper, Lamps, Panels - Scratch - Minimal / Rear Gate - Scratch - Minimal / Rear Gate - Modified - Small / (L) Side Gate - Scratch & Dent - Medium / (L) Center Panel - Scratch & Dent - Small / (L) Front Door, Molding - Scratch - Minimal / Front Bumper, Grille, Lamps - Scratch - Minimal / Front Panel - Scratch - Minimal
