General Information

Date & Time: 20, Dec, 2025 14:02

Make	Mitsubishi	Model	Mirage
YOM	2024	Odo Meter Reading	31,691
Registration No.	NKA2585	Chassis No.	PAEA13TJRRRA025507
CC	1.2	Transmission	CVT
Fuel Type	Gas	Type of Body	Sedan
Colour	Red

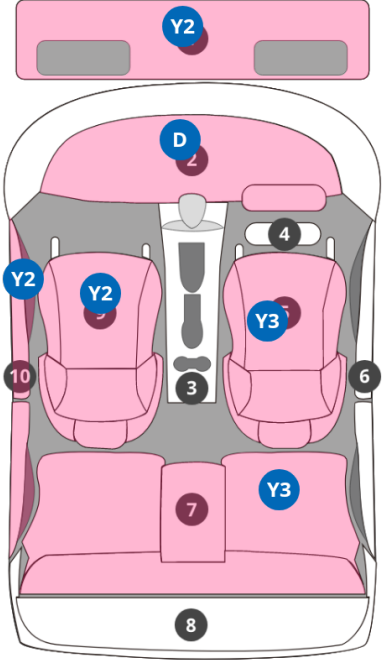
Interior Evaluation : B	Exterior Evaluation : E

<p>a : Cut, Fray d : Loose, Deformed k : Animal Hair s : Smell t : Cigarette Burns x : Defective y : Stain</p>

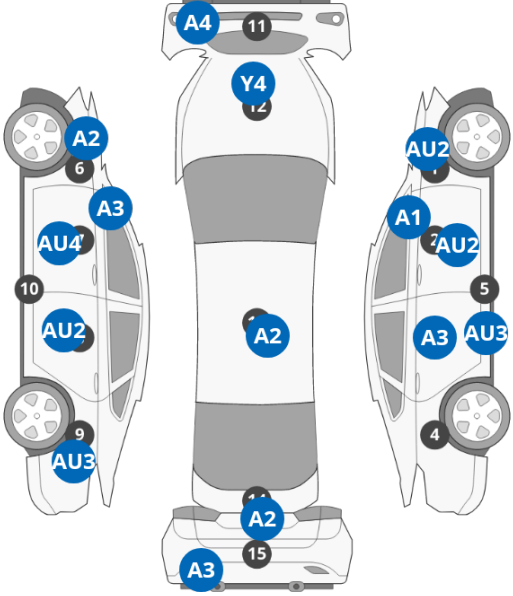
<p>A : Scratch AU : Scratch & Dent B : Modified C : Corrosion G : Stone chip P : Faded S : Rust SC : Rust & Corrosion U : Dent X : Defective Y : Crack, Gap</p>
<p>Remarks Rear Seat - Grime - Medium / (R) Front Seat - Grime - Medium / (L) Front Trim - Grime - Small / (L) Front Seat - Grime - Small / Dashboard - Traces of Adhesive Tape - Yes / Ceiling - Grime - Small</p>	<p>Remarks (R) Front Door - Repair Traces - Yes / (R) Front Fender - Repair Traces - Yes / Bonnet - Repair Traces - Yes / (L) Rear Fender - Repair Traces - Yes / Trunk Hood, Rear Gate - Repair Traces - Yes / Roof - Repair Traces - Yes / (L) Rear Fender, Molding - Scratch & Dent - Medium / (L) Rear Door, Molding - Scratch & Dent - Small / (L) Front Door, Molding - Scratch & Dent - Large / (L) Mirror - Scratch - Medium / (L) Front Fender, Molding - Scratch - Small / Bonnet, Headlight - Crack, Gap - Large / Front Bumper, Grille, Lamps - Scratch - Large / (R) Mirror - Scratch - Minimal / (R) Front Fender, Molding - Scratch & Dent - Small / (R) Front Door, Molding - Scratch & Dent - Small / (R) Step, In-panel, Side Spoiler - Scratch & Dent - Medium / (R) Rear Door, Molding - Scratch - Medium / Trunk Hood, Rear Gate - Scratch - Small / Rear Bumper, Lamps, Panels - Scratch - Medium / Roof - Scratch - Small</p>
