General Information

Date & Time: 15, Dec, 2025 10:26

Make	Mitsubishi	Model	L300
YOM	2025	Odo Meter Reading	18,143
Registration No.	NKG3351	Chassis No.	PAEL65MYSRB025362
CC	2.2	Transmission	M/T
Fuel Type	Diesel	Type of Body	FB Body
Colour	White

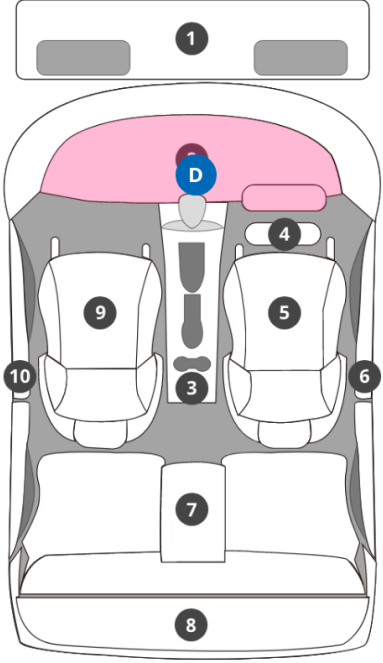
Interior Evaluation : A	Exterior Evaluation : E

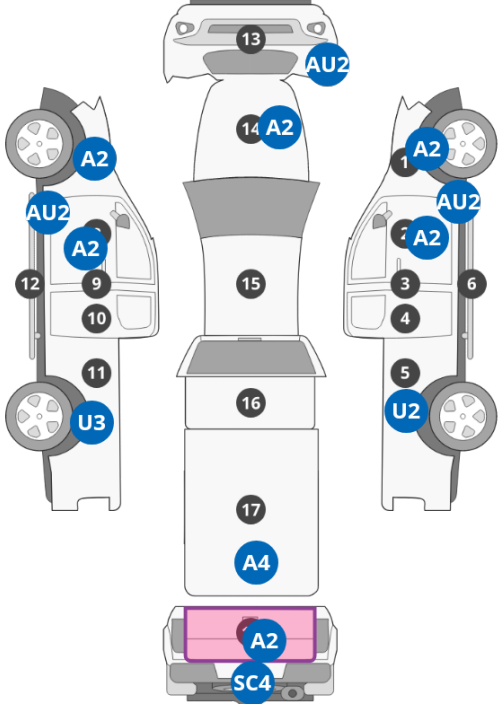
<p>A : Scratch AU : Scratch & Dent B : Modified C : Corrosion G : Stone chip P : Faded S : Rust SC : Rust & Corrosion U : Dent X : Defective Y : Crack, Gap</p>
<p>Remarks Dashboard - Traces of Adhesive Tape - Yes</p>	<p>Remarks (L) Rear Corner Panel - Repair Traces - Yes / Roof - Repair Traces - Yes / (L) Front Door, Molding - Scratch - Small / (L) Step, In-panel, Side Spoiler - Scratch & Dent - Small / (L) Side Gate - Dent - Medium / Rear Bumper, Lamps, Panels - Rust, Corrosion - Large / Cargo Bed Floor - Scratch - Large / (R) Side Gate - Dent - Small / (R) Front Door, Molding - Scratch - Small / (R) Step, In-panel, Side Spoiler - Scratch & Dent - Small / (L) Front Fender, Molding - Scratch - Small / (R) Front Fender, Molding - Scratch - Small / Front Panel - Scratch - Small / Front Bumper, Grille, Lamps - Scratch & Dent - Small / Rear Gate - Repair mark - Yes / Rear Gate - Scratch - Small</p>
