## General Information

| Make | Mitsubishi | Model | L300 |
| Registration No. | NKH4871 | Chassis No. | PAEL65MYSRB026861 |

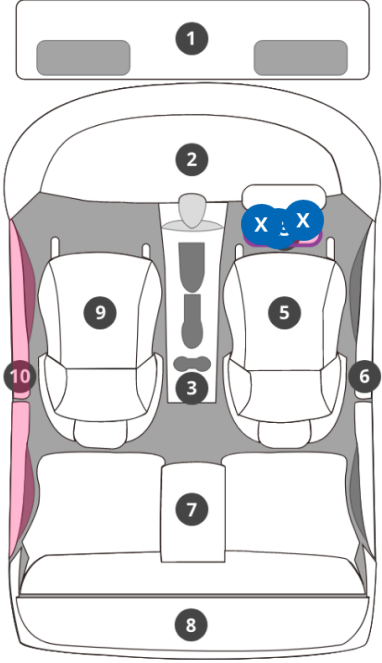
| Interior Evaluation : <b>B</b> | Exterior Evaluation : <b>E</b> |
|---|---|
| <p><b>Remarks</b><br/> Carpet - Worn, Scratch, Cut, Crack - Medium / (R) Front Floor Mat - Missing - Yes / (L) Front Floor Mat - Missing - Yes / Switchs - Missing - Yes</p> | <p><b>Remarks</b><br/> (R) Side Gate - Scratch &amp; Dent - Large / (R) Step, In-panel, Side Spoiler - Scratch &amp; Dent - Small / Front Bumper, Grille, Lamps - Scratch &amp; Dent - Medium / (R) Front Fender, Molding - Scratch - Medium / Front Panel - Scratch &amp; Dent - Small / (L) Front Door, Molding - Scratch - Small / (L) Step, In-panel, Side Spoiler - Scratch &amp; Dent - Small / (L) Side Gate - Scratch &amp; Dent - Large / Rear Gate - Scratch - Small / Rear Bumper, Lamps, Panels - Rust, Corrosion - Large / Cargo Bed Floor - Scratch - Large / (R) Front Door, Molding - Scratch - Small</p> |
