General Information

Make	Hyundai	Model	H100
YOM	2025	Odo Meter Reading	25,771
Registration No.	NKK5041	Chassis No.	KMFZBX7KASU166199
CC	2.5	Transmission	M/T
Fuel Type	Diesel	Type of Body	Shuttle
Colour	White

Body / Panel Condition

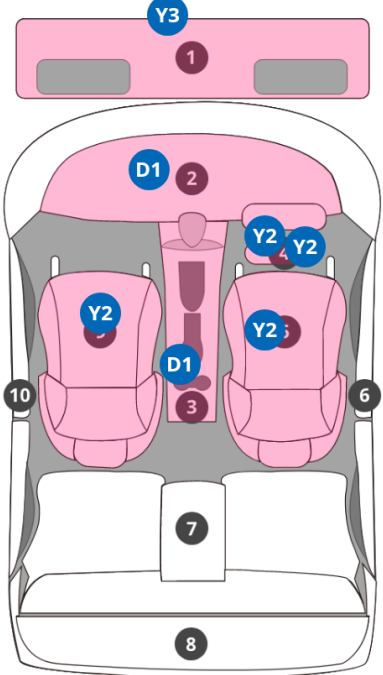
Interior Evaluation : B	Exterior Evaluation : C

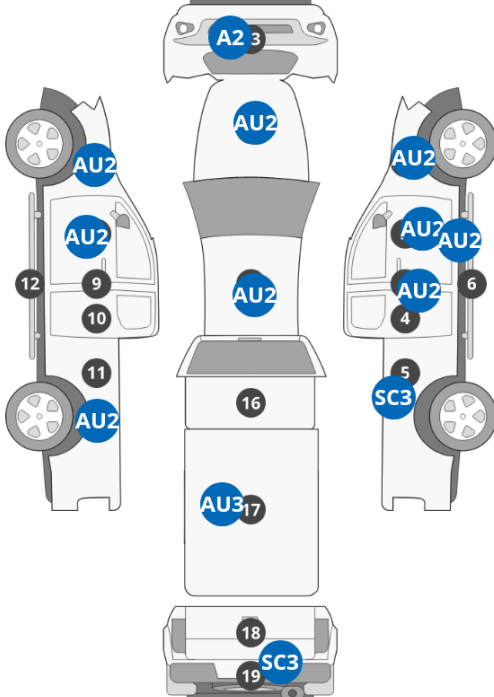
<p>A : Scratch AU : Scratch & Dent B : Modified C : Corrosion G : Stone chip P : Faded S : Rust SC : Rust & Corrosion U : Dent X : Defective Y : Crack, Gap</p>
<p>Remarks Ceiling - Grime - Medium / Console, Switchs, Vents - Worked - Minimal / (R) Front Seat - Grime - Small / (L) Front Seat - Grime - Small / Dashboard - Worked - Minimal / (L) Front Floor Mat - Grime - Small / (R) Front Floor Mat - Grime - Small</p>	<p>Remarks (L) Rear Corner Panel - Repair Traces - Yes / (L) Front Door, Molding - Scratch & Dent - Small / (L) Front Fender, Molding - Scratch & Dent - Small / Front Panel - Scratch & Dent - Small / (R) Front Fender, Molding - Scratch & Dent - Small / (R) Front Door, Molding - Scratch & Dent - Small / (R) Center Panel - Scratch & Dent - Small / (R) Side Gate - Rust, Corrosion - Medium / Rear Bumper, Lamps, Panels - Rust, Corrosion - Medium / Roof - Scratch & Dent - Small / Cargo Bed Floor - Scratch & Dent - Medium / (L) Side Gate - Scratch & Dent - Small / Front Bumper, Grille, Lamps - Scratch - Small</p>
