General Information

Make	Mitsubishi	Model	L300
YOM	2025	Odo Meter Reading	16,443
Registration No.	NKL9508	Chassis No.	PAEL65MYSRB027928
CC	2.2	Transmission	M/T
Fuel Type	Diesel	Type of Body	FB Body
Colour	White

Body / Panel Condition

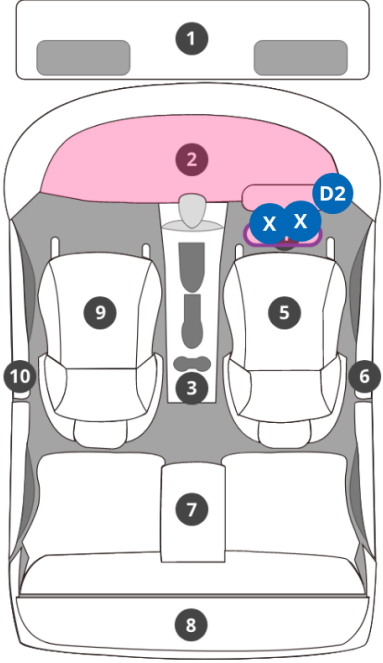
Interior Evaluation : B	Exterior Evaluation : D

<p>A : Scratch AU : Scratch & Dent B : Modified C : Corrosion G : Stone chip P : Faded S : Rust SC : Rust & Corrosion U : Dent X : Defective Y : Crack, Gap</p>
<p>Remarks (L) Front Floor Mat - Missing - Yes / (R) Front Floor Mat - Missing - Yes / Dashboard - Loose, Deformed - Small</p>	<p>Remarks Front Bumper, Grille, Lamps - Scratch - Medium / (R) Front Door, Molding - Scratch & Dent - Small / (R) Side Gate - Dent - Small / Rear Bumper, Lamps, Panels - Rust, Corrosion - Large / (L) Side Gate - Scratch & Dent - Medium / Front Panel - Scratch - Minimal / (L) Step, In-panel, Side Spoiler - Scratch & Dent - Small / (R) Front Fender, Molding - Scratch - Small / Cargo Bed Floor - Scratch - Large / Roof - Scratch & Dent - Large</p>
Frame Evaluation : A	Functional Evaluation : A
