General Information

Make	Mitsubishi	Model	L300
YOM	2025	Odo Meter Reading	21,972
Registration No.	NKK9664	Chassis No.	PAEL65MYSRB026175
CC	2.2	Transmission	M/T
Fuel Type	Diesel	Type of Body	FB Body
Colour	White

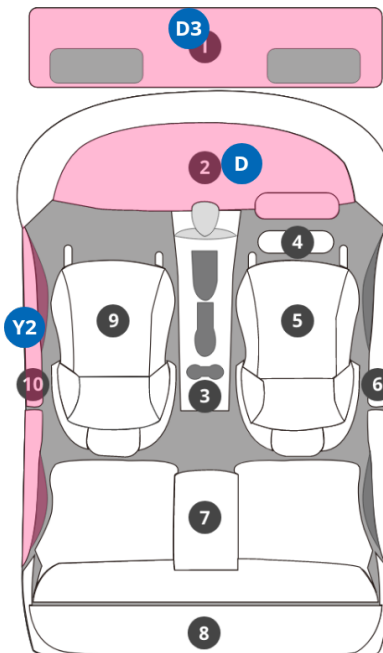
Interior Evaluation : B	Exterior Evaluation : C

<p>A : Scratch AU : Scratch & Dent B : Modified C : Corrosion G : Stone chip P : Faded S : Rust SC : Rust & Corrosion U : Dent X : Defective Y : Crack, Gap</p>
<p>Remarks Ceiling - Crinkle - Medium / Dashboard - Traces of Adhesive Tape - Yes / (L) Front Trim - Grime - Small</p>	<p>Remarks (L) Rear Corner Panel - Repair Traces - Yes / (R) Rear Corner Panel - Repair Traces - Yes / (R) Front Fender, Molding - Scratch - Minimal / (R) Front Door, Molding - Scratch - Minimal / (R) Center Panel - Scratch - Minimal / (R) Side Gate - Scratch & Dent - Medium / Rear Bumper, Lamps, Panels - Dent - Medium / Cargo Bed Floor - Scratch & Dent - Medium / Rear Gate - Scratch - Small / (L) Side Gate - Scratch & Dent - Large / (L) Center Panel - Scratch - Minimal / (L) Front Door, Molding - Scratch - Minimal / (L) Front Fender, Molding - Scratch - Minimal / Front Bumper, Grille, Lamps - Scratch & Dent - Medium / Front Panel - Scratch - Minimal / Roof - Scratch - Minimal</p>

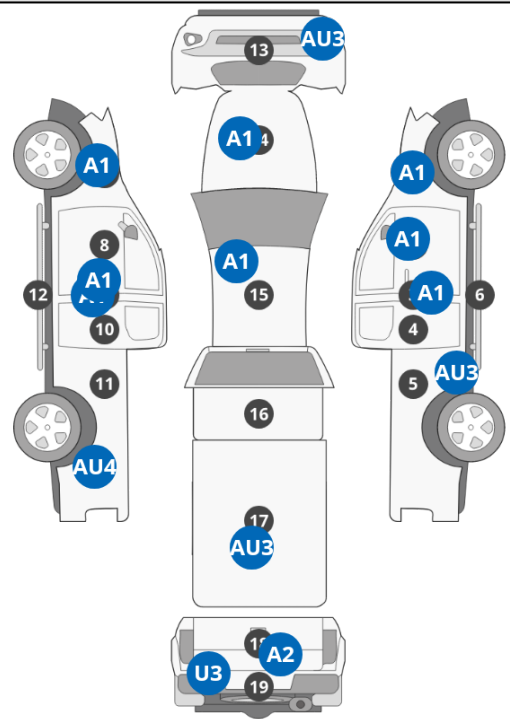
<p>Inspector Notes</p>
<p>no warranty booklet, jack and tools, with spare tire, with LTO plate, scratched and cracked tail light</p>
