## General Information

<b>Make</b>	Mitsubishi	<b>Model</b>	Montero SPT
<b>YOM</b>	2025	<b>Odo Meter Reading</b>	6,556
<b>Registration No.</b>	CCK1486	<b>Chassis No.</b>	MMBGJKR10SH00312
<b>CC</b>	2.4	<b>Transmission</b>	M/T
<b>Fuel Type</b>	Diesel	<b>Type of Body</b>	SUV
<b>Colour</b>	Silver

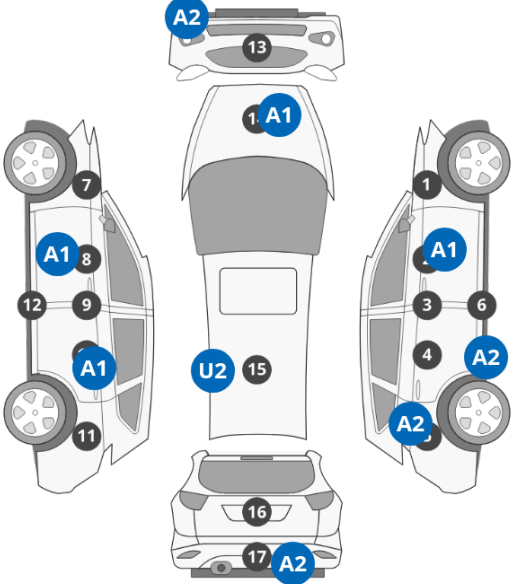
<p><b>A</b> : Scratch <b>AU</b> : Scratch &amp; Dent <b>B</b> : Modified <b>C</b> : Corrosion <b>G</b> : Stone chip <b>P</b> : Faded <b>S</b> : Rust <b>SC</b> : Rust &amp; Corrosion <b>U</b> : Dent <b>X</b> : Defective <b>Y</b> : Crack, Gap</p>
<b>Remarks</b> Mat Other - Missing - Yes	<b>Remarks</b> Front Bumper, Grille, Lamps - Scratch - Small / (R) Rear Fender, Molding - Scratch - Small / Rear Bumper, Lamps, Panels - Scratch - Small / (R) Front Door, Molding - Scratch - Minimal / (R) Step, In-panel, Side Spoiler - Scratch - Small / (L) Front Door, Molding - Scratch - Minimal / (L) Rear Door, Molding - Scratch - Minimal / Bonnet, Headlight - Scratch - Minimal / Roof - Dent - Small
