## General Information

<b>Make</b>	Toyota	<b>Model</b>	Yaris Cross
<b>YOM</b>	2024	<b>Odo Meter Reading</b>	4,942
<b>Registration No.</b>	GNW1358	<b>Chassis No.</b>	MHFAB8BF3P0012222
<b>CC</b>	1.5	<b>Transmission</b>	CVT
<b>Fuel Type</b>	Hybrid	<b>Type of Body</b>	SUV
<b>Colour</b>	Black

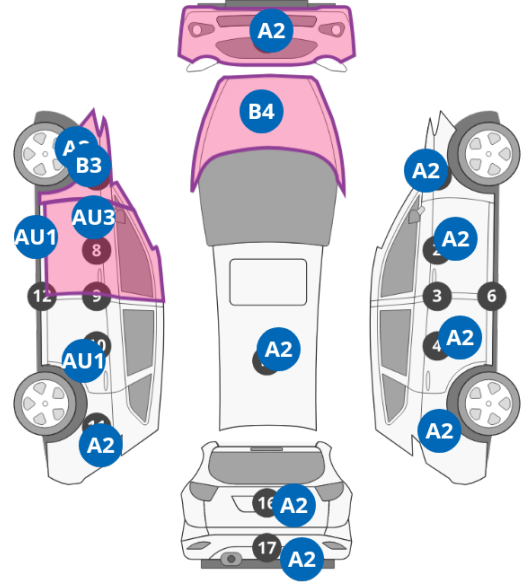
<p><b>A</b> : Scratch <b>AU</b> : Scratch &amp; Dent <b>B</b> : Modified <b>C</b> : Corrosion <b>G</b> : Stone chip <b>P</b> : Faded <b>S</b> : Rust <b>SC</b> : Rust &amp; Corrosion <b>U</b> : Dent <b>X</b> : Defective <b>Y</b> : Crack, Gap</p>
<p><b>Remarks</b> (L) Front Floor Mat - Grime - Medium / Rear Seat - Grime - Minimal / (R) Rear Trim - Grime - Minimal / (L) Rear Trim - Grime - Minimal / (R) Front Seat - Grime - Minimal / (L) Front Seat - Grime - Minimal</p>	<p><b>Remarks</b> Bonnet - Repair Traces - Yes / (L) Front Fender - Repair Traces - Yes / (L) Front Door - Repair Traces - Yes / (L) Front Door, Molding - Repair mark - Yes / (L) Front Fender, Molding - Repair mark - Yes / Bonnet, Headlight - Repair mark - Yes / Front Bumper, Grille, Lamps - Repair mark - Yes / (L) Front Door, Molding - Scratch &amp; Dent - Medium / (L) Front Fender, Molding - Scratch - Small / Front Bumper, Grille, Lamps - Scratch - Small / Bonnet, Headlight - Modified - Large / (L) Front Fender, Molding - Modified - Medium / (R) Front Fender, Molding - Scratch - Small / (R) Front Door, Molding - Scratch - Small / (R) Rear Door, Molding - Scratch - Small / (R) Rear Fender, Molding - Scratch - Small / Trunk Hood, Rear Gate - Scratch - Small / Rear Bumper, Lamps, Panels - Scratch - Small / (L) Rear Fender, Molding - Scratch - Small / (L) Rear Door, Molding - Scratch &amp; Dent - Minimal / (L) Step, In-panel, Side Spoiler - Scratch &amp; Dent - Minimal / Roof - Scratch - Small</p>
